# Access Compliance Report

## Public Rights-of-Way

### (Curb Ramps)

| Intersection ID: 11423 | Main Street: S_SUMMIT_AV | Cross Street: W_4TH_ST_EXT | Location: S |

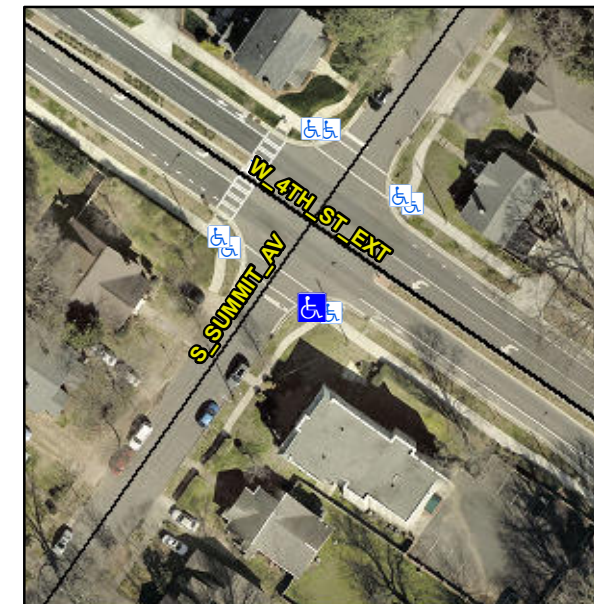
**N/A**

| Compliance | Description | Data | Compliance | Description | Data |
|---|---|---|---|---|---|
| N/A | Landing Curb? (Y/N) | No | No | DWS Offset (in) | 5.0 |

Possible Solutions:

**Remove & Replace Detectable Warning System.**

**R305.2**

\$ 800.00
