# Access Compliance Report

## Public Rights-of-Way

### (Curb Ramps)

Intersection ID: 10020684	Main Street: BEAM_RD	Cross Street: N/A	Location: SW
ADA ID: 2D6CE02BE5D9	Ramp Type: PerpDiag	Initial Pass/Fail: Fail	Overall Compliance: No
			Severity Score: 13.75

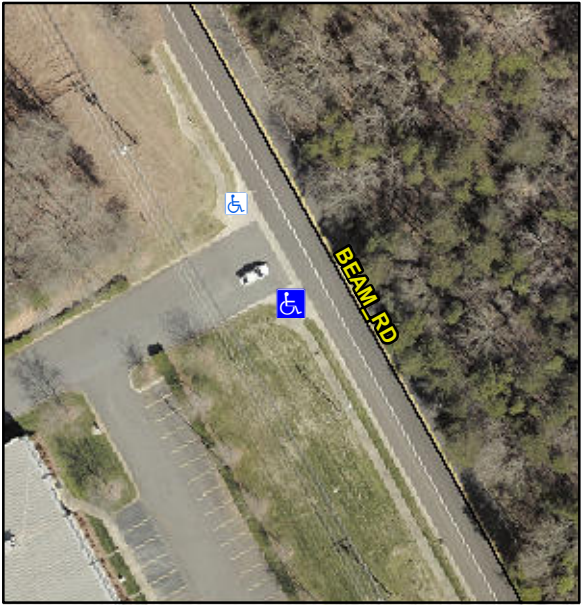
Possible Solutions:	Compliance	Description	Data	Compliance	Description	Data
	Remove & Replace Curb Ramp With Two New Directional Ramps or Equivalent.	N/A	Ramp Length (in)	60.5	No	Ramp Slope (%)	8.7
		Yes	Ramp Width (in)	53.0	No	Ramp XSlope (%)	4.5
		N/A	Flare Type LT	N/A	N/A	Flare Type RT	N/A
		N/A	Flare Slope LT (%)	N/A	N/A	Flare Slope RT (%)	N/A
		N/A	Flare Traversable LT?	N/A	N/A	Flare Traversable RT?	N/A
		N/A	Landing Length (in)	N/A	N/A	DWS Provided?	N/A
		N/A	Landing Width (in)	N/A	N/A	DWS Contrast?	N/A
		N/A	Landing Slope (%)	N/A	N/A	DWS Length (in)	N/A
		N/A	Landing X Slope (%)	N/A	N/A	DWS Full Width?	N/A
		N/A	Landing Curb? (Y/N)	N/A	N/A	DWS Offset (in)	N/A
		N/A	Shared Landing?	N/A			
		N/A	Gutter Ponding?	N/A	N/A	Gutter Slope (%)	N/A
		N/A	Gutter Lip Ht (in)	N/A	N/A	Gutter X Slope (%)	N/A
		N/A	Painted X Walk1?	No	N/A	Painted X Walk2?	No

X Walk 1 Direction	To E		X Walk 2 Direction	To N
		N/A	X Walk 1 Width (in)	N/A	N/A	X Walk 2 Width (in)	N/A
			X Walk 1 Slope (%)	2.9		X Walk 2 Slope (%)	4.0
			X Walk 1 X Slope (%)	3.2		X Walk 2 X Slope (%)	0.8
		N/A	Ramp inside XWalk1?	N/A	N/A	Ramp inside XWalk2?	N/A
<p>Surveyor Notes:</p> <p>N/A</p> <p>PROW/ADA:</p> <p>Not Found, R304.2.2, R304.5.3</p>			Road Slope (%)	1.5	N/A	Clear Space?	N/A
			Road X Slope (%)	4.5	N/A	Clear Space to XWalk (in)	N/A
		N/A	Any Obstructions?	N/A	N/A	Storm Grate/Utility Hazard?	N/A
			Obstruction Type			Storm Grate/Utility Type	
					N/A		N/A
					Yes	Surface Condition? (G/P)	Good
