Access Compliance Report

(Curb Ramps)

Intersection ID: 30016	Main Street: KEMPSFORD_DR	Cross Street: LUTON_CT	Location: SE
ADA ID: 2D6D27893144	Ramp Type: PerpDiag	Initial Pass/Fail: Fail	Overall Compliance: No
		Severity Score: 0

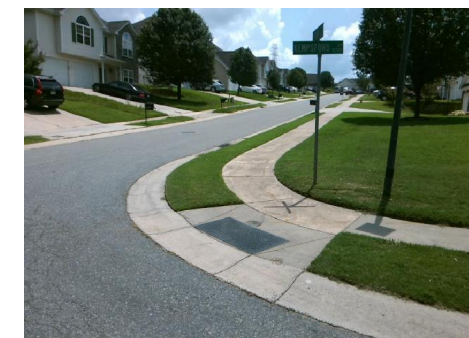
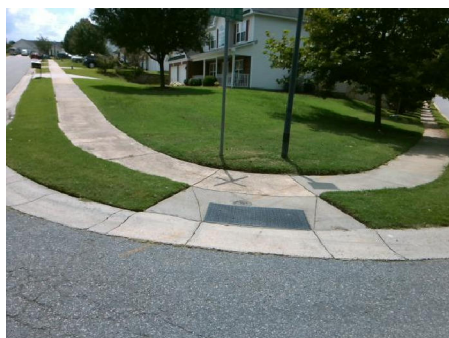
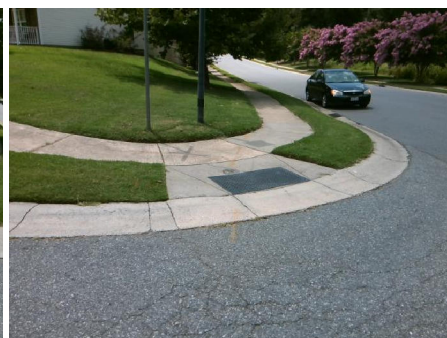
Compliance	Description	Data	Compliance	Description	Data
N/A	Ramp Length (in)	46.0	Yes	Ramp Slope (%)	5.0
Yes	Ramp Width (in)	50.0	Yes	Ramp XSlope (%)	0.9
N/A	Flare Type LT	N/A	N/A	Flare Type RT	N/A
N/A	Flare Slope LT (%)	N/A	N/A	Flare Slope RT (%)	N/A
N/A	Flare Traversable LT?	N/A	N/A	Flare Traversable RT?	N/A
N/A	Landing Length (in)	N/A	N/A	DWS Provided?	N/A
N/A	Landing Width (in)	N/A	N/A	DWS Contrast?	N/A
N/A	Landing Slope (%)	N/A	N/A	DWS Length (in)	N/A
N/A	Landing X Slope (%)	N/A	N/A	DWS Full Width?	N/A
N/A	Landing Curb? (Y/N)	N/A	N/A	DWS Offset (in)	N/A
N/A	Shared Landing?	N/A			
N/A	Gutter Ponding?	N/A	N/A	Gutter Slope (%)	N/A
N/A	Gutter Lip Ht (in)	N/A	N/A	Gutter X Slope (%)	N/A
N/A	Painted X Walk1?	No	N/A	Painted X Walk2?	No
	X Walk 1 Direction	To N		X Walk 2 Direction	To W
N/A	X Walk 1 Width (in)	N/A	N/A	X Walk 2 Width (in)	N/A
	X Walk 1 Slope (%)	1.8		X Walk 2 Slope (%)	1.7
	X Walk 1 X Slope (%)	0.8		X Walk 2 X Slope (%)	0.8

N/A	Ramp inside XWalk1?	N/A	N/A	Ramp inside XWalk2?	N/A
	Road Slope (%)	1.7	N/A	Clear Space?	N/A
	Road X Slope (%)	0.3	N/A	Clear Space to XWalk (in)	N/A
N/A	Any Obstructions?	N/A	N/A	Storm Grate/Utility Hazard?	N/A
	Obstruction Type			Storm Grate/Utility Type	
		N/A			N/A
			Yes	Surface Condition? (G/P)	Good

Remove & Replace Curb Ramp With Two New Directional Ramps or Equivalent.
