Access Compliance Report

Public Rights-of-Way

(Curb Ramps)

Intersection ID: 10019902	Main Street: ARCO_CORPORATE_DR	Cross Street: N/A	Location: NE
ADA ID: 2D7190731970	Ramp Type: PerpDiag	Initial Pass/Fail: Fail	Overall Compliance: No
Codes/Mitigation Info/Possible Solution		Field Measurements/Component Compliance

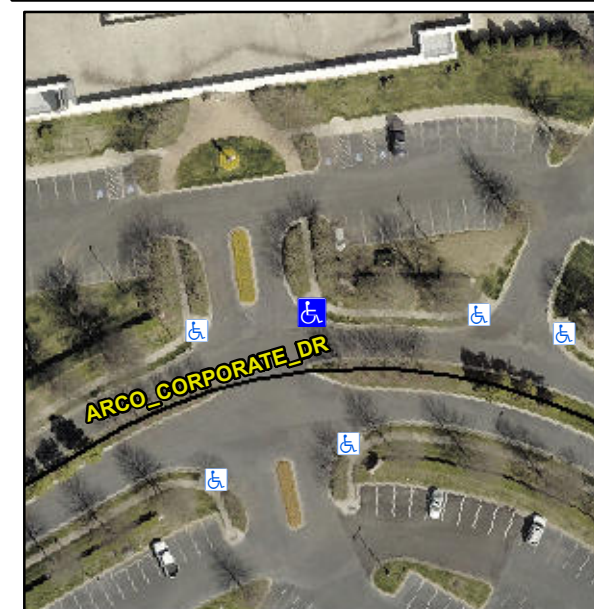
Not Found, R304.5.1

Compliance	Description	Data	Compliance	Description	Data
N/A	Ramp Length (in)	55.0	Yes	Ramp Slope (%)	7.3
No	Ramp Width (in)	36.0	Yes	Ramp XSlope (%)	3.5
N/A	Flare Type LT	N/A	N/A	Flare Type RT	N/A
N/A	Flare Slope LT (%)	N/A	N/A	Flare Slope RT (%)	N/A
N/A	Flare Traversable LT?	N/A	N/A	Flare Traversable RT?	N/A
N/A	Landing Length (in)	N/A	N/A	DWS Provided?	N/A
N/A	Landing Width (in)	N/A	N/A	DWS Contrast?	N/A
N/A	Landing Slope (%)	N/A	N/A	DWS Length (in)	N/A
N/A	Landing X Slope (%)	N/A	N/A	DWS Full Width?	N/A
N/A	Landing Curb? (Y/N)	N/A	N/A	DWS Offset (in)	N/A
N/A	Shared Landing?	N/A			
N/A	Gutter Ponding?	N/A	N/A	Gutter Slope (%)	N/A
N/A	Gutter Lip Ht (in)	N/A	N/A	Gutter X Slope (%)	N/A
N/A	Painted X Walk1?	No	N/A	Painted X Walk2?	No
	X Walk 1 Direction	To W		X Walk 2 Direction	To S
N/A	X Walk 1 Width (in)	N/A	N/A	X Walk 2 Width (in)	N/A
	X Walk 1 Slope (%)	1.9		X Walk 2 Slope (%)	2.8
	X Walk 1 X Slope (%)	3.3		X Walk 2 X Slope (%)	5.0

N/A	Ramp inside XWalk1?	N/A	N/A	Ramp inside XWalk2?	N/A
	Road Slope (%)	4.6	N/A	Clear Space?	N/A
	Road X Slope (%)	0.6	N/A	Clear Space to XWalk (in)	N/A
N/A	Any Obstructions?	N/A	N/A	Storm Grate/Utility Hazard?	N/A
	Obstruction Type			Storm Grate/Utility Type	
		N/A			N/A
			Yes	Surface Condition? (G/P)	Good

Remove & Replace Curb Ramp With Two New Directional Ramps or Equivalent.
