Access Compliance Report

Public Rights-of-Way

(Curb Ramps)

Intersection ID: 8417	Main Street: POINSETT_ST	Cross Street: WAINWRIGHT_AV	Location: SE
ADA ID: 2D77C7C68E00	Ramp Type: PerpDiag	Initial Pass/Fail: Fail	Overall Compliance: No
Codes/Mitigation Info/Possible Solution		Field Measurements/Component Compliance	
Severity Score: 12.5

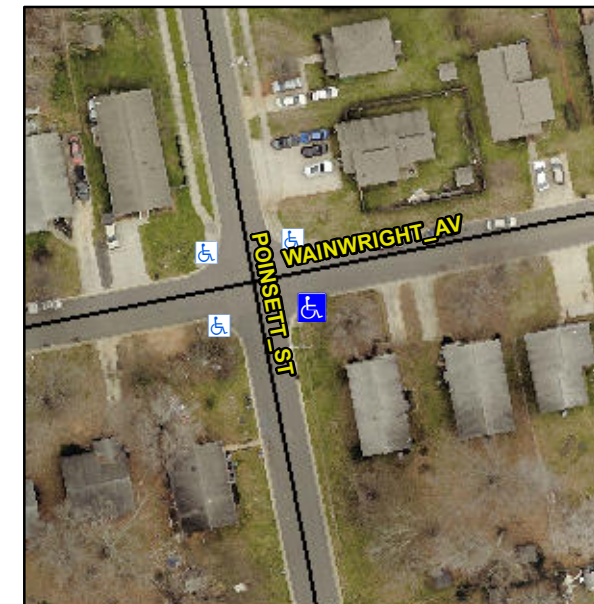
Compliance	Description	Data	Compliance	Description	Data
N/A	Ramp Length (in)	58.5	Yes	Ramp Slope (%)	6.8
Yes	Ramp Width (in)	48.0	No	Ramp XSlope (%)	5.1
N/A	Flare Type LT	N/A	N/A	Flare Type RT	N/A
N/A	Flare Slope LT (%)	N/A	N/A	Flare Slope RT (%)	N/A
N/A	Flare Traversable LT?	N/A	N/A	Flare Traversable RT?	N/A
N/A	Landing Length (in)	N/A	N/A	DWS Provided?	N/A
N/A	Landing Width (in)	N/A	N/A	DWS Contrast?	N/A
N/A	Landing Slope (%)	N/A	N/A	DWS Length (in)	N/A
N/A	Landing X Slope (%)	N/A	N/A	DWS Full Width?	N/A
N/A	Landing Curb? (Y/N)	N/A	N/A	DWS Offset (in)	N/A
N/A	Shared Landing?	N/A			
N/A	Gutter Ponding?	N/A	N/A	Gutter Slope (%)	N/A
N/A	Gutter Lip Ht (in)	N/A	N/A	Gutter X Slope (%)	N/A
N/A	Painted X Walk1?	No	N/A	Painted X Walk2?	No
	X Walk 1 Direction	To N		X Walk 2 Direction	To W
N/A	X Walk 1 Width (in)	N/A	N/A	X Walk 2 Width (in)	N/A
	X Walk 1 Slope (%)	9.8		X Walk 2 Slope (%)	1.5
	X Walk 1 X Slope (%)	0.2		X Walk 2 X Slope (%)	6.8

N/A	Ramp inside XWalk1?	N/A	N/A	Ramp inside XWalk2?	N/A
	Road Slope (%)	3.3	N/A	Clear Space?	N/A
	Road X Slope (%)	4.8	N/A	Clear Space to XWalk (in)	N/A
N/A	Any Obstructions?	N/A	N/A	Storm Grate/Utility Hazard?	N/A
	Obstruction Type			Storm Grate/Utility Type	
		N/A			N/A
			Yes	Surface Condition? (G/P)	Good

Remove & Replace Curb Ramp With Two New Directional Ramps or Equivalent.

Not Found, R304.5.3
