Access Compliance Report

Public Rights-of-Way

(Curb Ramps)

Intersection ID: 28067	Main Street: LANDEN_DR	Cross Street: SOUTH_BEND_LN	Location: SE
ADA ID: 2D80CB896F6A	Ramp Type: Perp	Initial Pass/Fail: Pass	Overall Compliance: No
Codes/Mitigation Info/Possible Solution		Field Measurements/Component Compliance	
Severity Score: 20

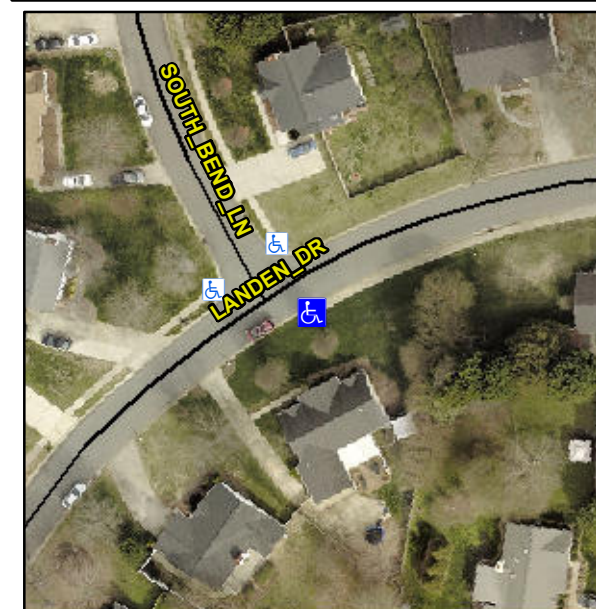
Not Found, R304.2.1, R304.2.2-Perp, R304.3.2-Para, R304.5.3, R305

Compliance	Description	Data	Compliance	Description	Data
N/A	Ramp Length (in)	48.0	Yes	Ramp Slope (%)	6.2
Yes	Ramp Width (in)	48.0	Yes	Ramp XSlope (%)	1.2
N/A	Flare Type LT	Sloped	N/A	Flare Type RT	N/A
N/A	Flare Slope LT (%)	4.1	N/A	Flare Slope RT (%)	0.5
N/A	Flare Traversable LT?	Yes	N/A	Flare Traversable RT?	No
No	Landing Length (in)	N/A	No	DWS Provided?	No
No	Landing Width (in)	N/A	N/A	DWS Contrast?	No
No	Landing Slope (%)	N/A	N/A	DWS Length (in)	N/A
No	Landing X Slope (%)	N/A	N/A	DWS Full Width?	No
N/A	Landing Curb? (Y/N)	No	N/A	DWS Offset (in)	N/A
N/A	Shared Landing?	No			
Yes	Gutter Ponding?	No	Yes	Gutter Slope (%)	2.1
Yes	Gutter Lip Ht (in)	0.0	Yes	Gutter X Slope (%)	0.7
N/A	Painted X Walk1?	No	N/A	Painted X Walk2?	N/A
	X Walk 1 Direction	To NW		X Walk 2 Direction	N/A
N/A	X Walk 1 Width (in)	N/A	N/A	X Walk 2 Width (in)	N/A
	X Walk 1 Slope (%)	3.8		X Walk 2 Slope (%)	N/A
	X Walk 1 X Slope (%)	1.2		X Walk 2 X Slope (%)	N/A

N/A	Ramp inside XWalk1?	N/A	N/A	Ramp inside XWalk2?	N/A
	Road Slope (%)	N/A	N/A	Clear Space?	Yes
	Road X Slope (%)	N/A	N/A	Clear Space to XWalk (in)	N/A
Yes	Any Obstructions?	No	Yes	Storm Grate/Utility Hazard?	No
	Obstruction Type			Storm Grate/Utility Type	
		N/A			N/A
			Yes	Surface Condition? (G/P)	Good

Remove & Replace Entire Ramp.

Total Cost: \$ 1850.00
