Access Compliance Report

Public Rights-of-Way (Curb Ramps)

Intersection ID: 10038355	Main Street: SOUTH_BV	Cross Street: N/A	Location: NW
ADA ID: 2D8BC05E7DFD	Ramp Type: Perp	Initial Pass/Fail: Fail	Overall Compliance: No
Severity Score: 33.75			
Codes/Mitigation Info/Possible Solution		Field Measurements/Component Compliance

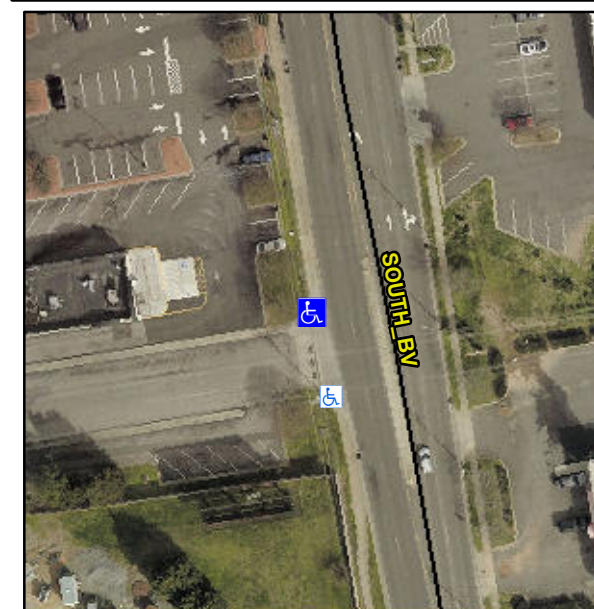
Not Found, R304.5.1, R304.2.2, R304.5.3

Compliance	Description	Data	Compliance	Description	Data
N/A	Ramp Length (in)	61.0	No	Ramp Slope (%)	9.9
No	Ramp Width (in)	46.5	No	Ramp XSlope (%)	6.5
N/A	Flare Type LT	N/A	N/A	Flare Type RT	N/A
N/A	Flare Slope LT (%)	N/A	N/A	Flare Slope RT (%)	N/A
N/A	Flare Traversable LT?	N/A	N/A	Flare Traversable RT?	N/A
N/A	Landing Length (in)	N/A	N/A	DWS Provided?	N/A
N/A	Landing Width (in)	N/A	N/A	DWS Contrast?	N/A
N/A	Landing Slope (%)	N/A	N/A	DWS Length (in)	N/A
N/A	Landing X Slope (%)	N/A	N/A	DWS Full Width?	N/A
N/A	Landing Curb? (Y/N)	N/A	N/A	DWS Offset (in)	N/A
N/A	Shared Landing?	N/A			
N/A	Gutter Ponding?	N/A	N/A	Gutter Slope (%)	N/A
N/A	Gutter Lip Ht (in)	N/A	N/A	Gutter X Slope (%)	N/A
N/A	Painted X Walk1?	No	N/A	Painted X Walk2?	N/A
	X Walk 1 Direction	To S		X Walk 2 Direction	N/A
N/A	X Walk 1 Width (in)	N/A	N/A	X Walk 2 Width (in)	N/A
	X Walk 1 Slope (%)	4.6		X Walk 2 Slope (%)	N/A
	X Walk 1 X Slope (%)	10.5		X Walk 2 X Slope (%)	N/A

N/A	Ramp inside XWalk1?	N/A	N/A	Ramp inside XWalk2?	N/A
	Road Slope (%)	N/A	N/A	Clear Space?	N/A
	Road X Slope (%)	N/A	N/A	Clear Space to XWalk (in)	N/A
N/A	Any Obstructions?	N/A	N/A	Storm Grate/Utility Hazard?	N/A
	Obstruction Type			Storm Grate/Utility Type	
		N/A			N/A
			Yes	Surface Condition? (G/P)	Good

Remove & Replace Entire Ramp.

\$ 1850.00
