# Access Compliance Report

## Public Rights-of-Way

### (Curb Ramps)

Intersection ID: 18900	Main Street: CLIFTON_MEADOW_DR	Cross Street: TWIN_FALLS_LN	Location: SE
ADA ID: 2D9295E45A14	Ramp Type: PerpDiag	Initial Pass/Fail: Fail	Overall Compliance: No
Severity Score: 1.25			
Codes/Mitigation Info/Possible Solution		Field Measurements/Component Compliance

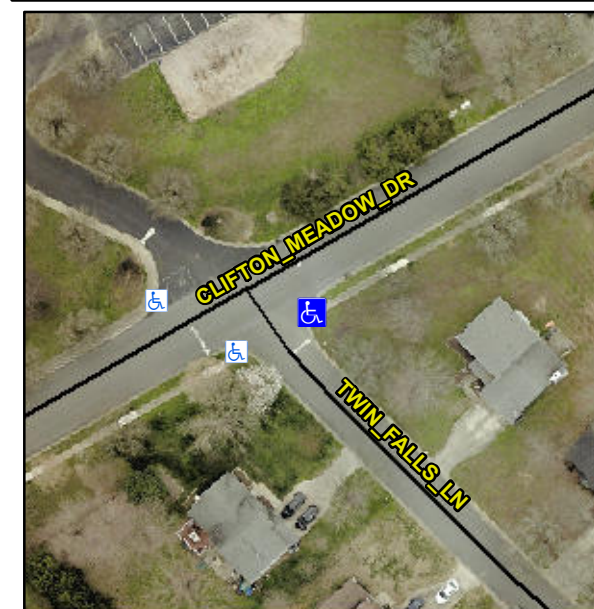
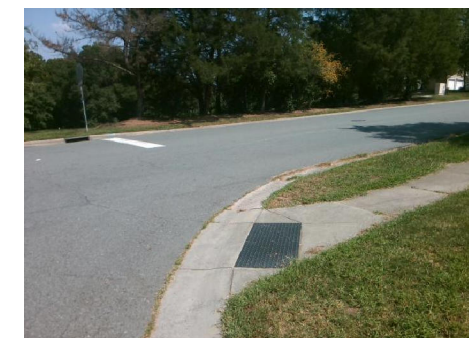
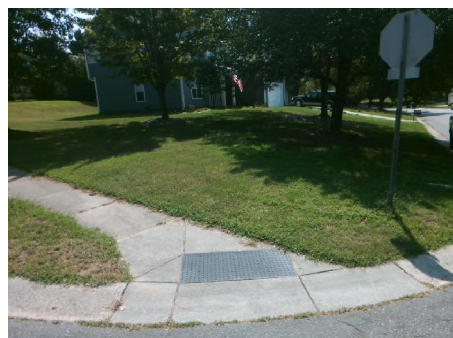
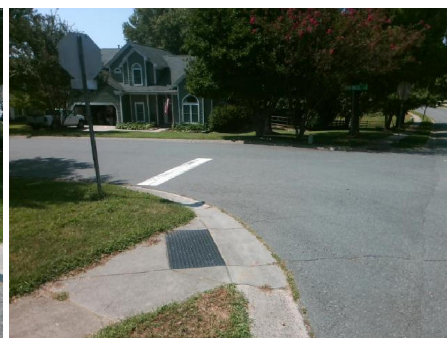
**Not Found, R304.5.3**

Compliance	Description	Data	Compliance	Description	Data
N/A	Ramp Length (in)	27.0	Yes	Ramp Slope (%)	7.5
Yes	Ramp Width (in)	48.0	No	Ramp XSlope (%)	3.8
N/A	Flare Type LT	N/A	N/A	Flare Type RT	N/A
N/A	Flare Slope LT (%)	N/A	N/A	Flare Slope RT (%)	N/A
N/A	Flare Traversable LT?	N/A	N/A	Flare Traversable RT?	N/A
N/A	Landing Length (in)	N/A	N/A	DWS Provided?	N/A
N/A	Landing Width (in)	N/A	N/A	DWS Contrast?	N/A
N/A	Landing Slope (%)	N/A	N/A	DWS Length (in)	N/A
N/A	Landing X Slope (%)	N/A	N/A	DWS Full Width?	N/A
N/A	Landing Curb? (Y/N)	N/A	N/A	DWS Offset (in)	N/A
N/A	Shared Landing?	N/A			
N/A	Gutter Ponding?	N/A	N/A	Gutter Slope (%)	N/A
N/A	Gutter Lip Ht (in)	N/A	N/A	Gutter X Slope (%)	N/A
N/A	Painted X Walk1?	No	N/A	Painted X Walk2?	No
	X Walk 1 Direction	To NW		X Walk 2 Direction	To SW
N/A	X Walk 1 Width (in)	N/A	N/A	X Walk 2 Width (in)	N/A
	X Walk 1 Slope (%)	6.6		X Walk 2 Slope (%)	4.8
	X Walk 1 X Slope (%)	3.9		X Walk 2 X Slope (%)	1.3

N/A	Ramp inside XWalk1?	N/A	N/A	Ramp inside XWalk2?	N/A
	Road Slope (%)	4.4	N/A	Clear Space?	N/A
	Road X Slope (%)	1.8	N/A	Clear Space to XWalk (in)	N/A
N/A	Any Obstructions?	N/A	N/A	Storm Grate/Utility Hazard?	N/A
	Obstruction Type			Storm Grate/Utility Type	
		N/A			N/A
		Yes		Surface Condition? (G/P)	Good

**Remove & Replace Curb Ramp With Two New Directional Ramps or Equivalent.**

Total Cost: \$ 3200.00
