Access Compliance Report

Public Rights-of-Way

(Curb Ramps)

Intersection ID: 30010	Main Street: BACKWATER_DR	Cross Street: SMOOTHSTONE_LN	Location: SW
ADA ID: 2D941923B0FB	Ramp Type: PerpDiag	Initial Pass/Fail: Fail	Overall Compliance: No
		Severity Score: 10

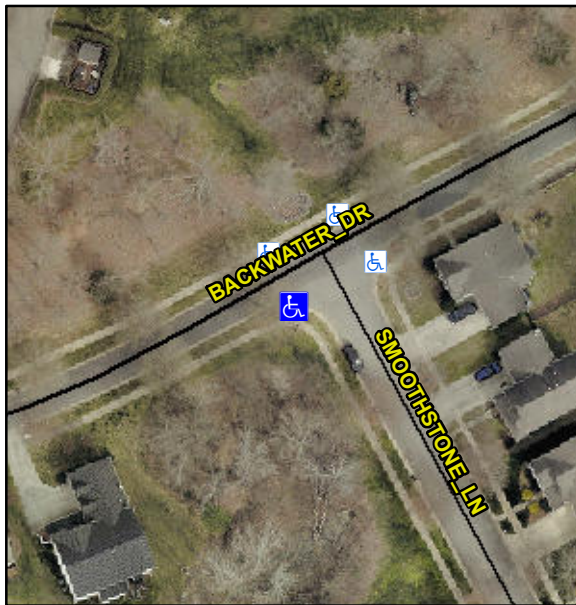
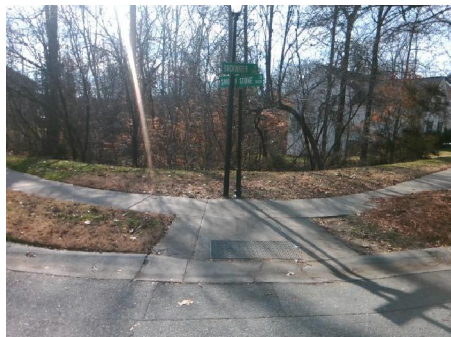
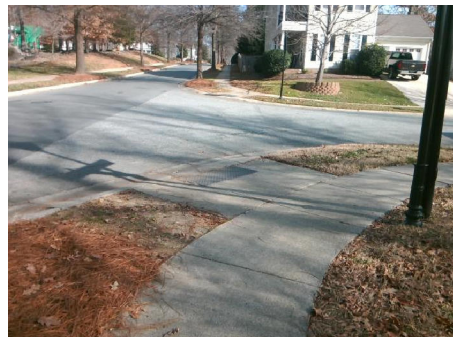
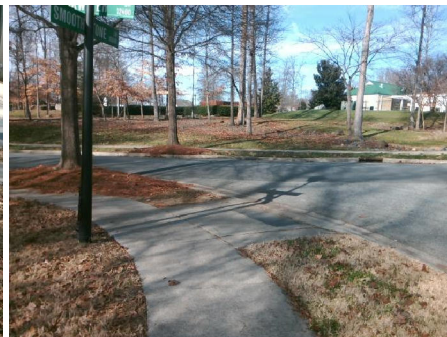
Not Found, R304.5.1, R304.5.3

Compliance	Description	Data	Compliance	Description	Data
N/A	Ramp Length (in)	69.0	Yes	Ramp Slope (%)	5.7
No	Ramp Width (in)	47.4	No	Ramp XSlope (%)	3.5
N/A	Flare Type LT	N/A	N/A	Flare Type RT	N/A
N/A	Flare Slope LT (%)	N/A	N/A	Flare Slope RT (%)	N/A
N/A	Flare Traversable LT?	N/A	N/A	Flare Traversable RT?	N/A
N/A	Landing Length (in)	N/A	N/A	DWS Provided?	N/A
N/A	Landing Width (in)	N/A	N/A	DWS Contrast?	N/A
N/A	Landing Slope (%)	N/A	N/A	DWS Length (in)	N/A
N/A	Landing X Slope (%)	N/A	N/A	DWS Full Width?	N/A
N/A	Landing Curb? (Y/N)	N/A	N/A	DWS Offset (in)	N/A
N/A	Shared Landing?	N/A			
N/A	Gutter Ponding?	N/A	N/A	Gutter Slope (%)	N/A
N/A	Gutter Lip Ht (in)	N/A	N/A	Gutter X Slope (%)	N/A
N/A	Painted X Walk1?	No	N/A	Painted X Walk2?	No
	X Walk 1 Direction	To E		X Walk 2 Direction	To N
N/A	X Walk 1 Width (in)	N/A	N/A	X Walk 2 Width (in)	N/A
	X Walk 1 Slope (%)	5.5		X Walk 2 Slope (%)	4.6
	X Walk 1 X Slope (%)	4.4		X Walk 2 X Slope (%)	4.5

N/A	Ramp inside XWalk1?	N/A	N/A	Ramp inside XWalk2?	N/A
	Road Slope (%)	1.0	N/A	Clear Space?	N/A
	Road X Slope (%)	9.7	N/A	Clear Space to XWalk (in)	N/A
N/A	Any Obstructions?	N/A	N/A	Storm Grate/Utility Hazard?	N/A
	Obstruction Type			Storm Grate/Utility Type	
		N/A			N/A
			Yes	Surface Condition? (G/P)	Good

Remove & Replace Curb Ramp With Two New Directional Ramps or Equivalent.
