Access Compliance Report

Public Rights-of-Way

(Curb Ramps)

Intersection ID: 12446	Main Street: ASHLAND_AV	Cross Street: BELVEDERE_AV	Location: NE
ADA ID: 2D97FCAA5E81	Ramp Type: BlendTrans1	Initial Pass/Fail: Fail	Overall Compliance: No
Codes/Mitigation Info/Possible Solution		Field Measurements/Component Compliance	
Severity Score: 1.25

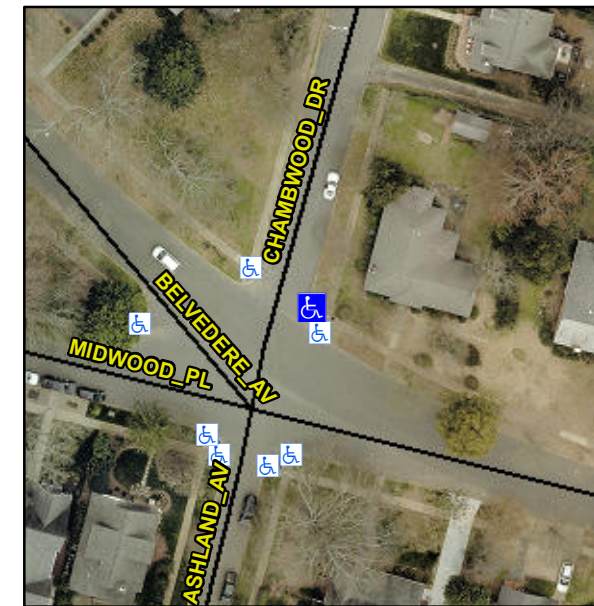
Compliance	Description	Data	Compliance	Description	Data
N/A	Ramp Length (in)	88.0	Yes	BlendTrans Slope (%)	1.6
Yes	Ramp Width (in)	55.0	No	BlendTrans XSlope (%)	3.3
N/A	Flare Type LT	N/A	N/A	Flare Type RT	N/A
N/A	Flare Slope LT (%)	N/A	N/A	Flare Slope RT (%)	N/A
N/A	Flare Traversable LT?	N/A	N/A	Flare Traversable RT?	N/A
N/A	Landing Length (in)	N/A	N/A	DWS Provided?	N/A
N/A	Landing Width (in)	N/A	N/A	DWS Contrast?	N/A
N/A	Landing Slope (%)	N/A	N/A	DWS Length (in)	N/A
N/A	Landing X Slope (%)	N/A	N/A	DWS Full Width?	N/A
N/A	Landing Curb? (Y/N)	N/A	N/A	DWS Offset (in)	N/A
N/A	Shared Landing?	N/A			
N/A	Gutter Ponding?	N/A	N/A	Gutter Slope (%)	N/A
N/A	Gutter Lip Ht (in)	3.0	N/A	Gutter X Slope (%)	N/A
N/A	Painted X Walk1?	No	N/A	Painted X Walk2?	N/A
	X Walk 1 Direction	To NW		X Walk 2 Direction	N/A
	X Walk 1 Width (in)	N/A		X Walk 2 Width (in)	N/A
	X Walk 1 Slope (%)	4.1		X Walk 2 Slope (%)	N/A
	X Walk 1 X Slope (%)	1.2		X Walk 2 X Slope (%)	N/A

N/A	Ramp inside XWalk1?	N/A	N/A	Ramp inside XWalk2?	N/A
	Road Slope (%)	1.2		Clear Space?	N/A
	Road X Slope (%)	4.1	N/A	Clear Space to XWalk (in)	N/A
N/A	Any Obstructions?	N/A	N/A	Storm Grate/Utility Hazard?	N/A
	Obstruction Type			Storm Grate/Utility Type	
		N/A			N/A
			Yes	Surface Condition? (G/P)	Good
			N/A	Curb Slope (%)	N/A

Remove & Replace Curb Ramp With Two New Directional Ramps or Equivalent.

R304.5.3
