Access Compliance Report

Public Rights-of-Way

(Curb Ramps)

Intersection ID: 20516	Main Street: OLD_PINEVILLE_RD	Cross Street: SILVERLEAF_RD	Location: SW
ADA ID: 2DA3A6BD964A	Ramp Type: Directional1	Initial Pass/Fail: Fail	Overall Compliance: No
		Severity Score: 1.25

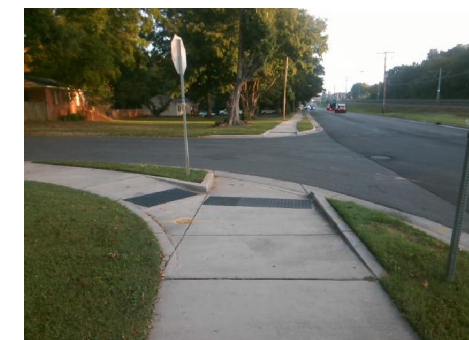
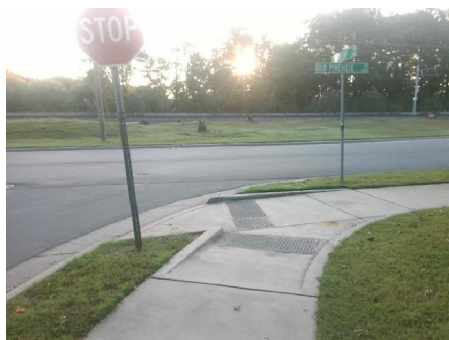
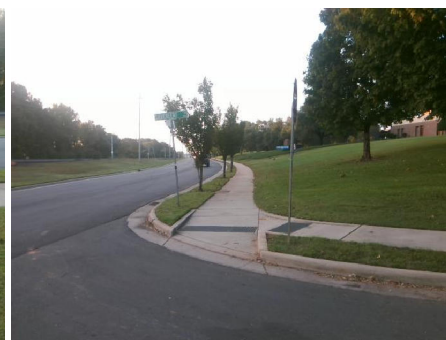
Compliance	Description	Data	Compliance	Description	Data
N/A	Ramp Length (in)	121.0	N/A	Grade Break?	N/A
Yes	Ramp Width (in)	78.0	N/A	Grade Break Slope (%)	0.0
Yes	Ramp Slope (%)	2.7	N/A	Grade Break XSlope (%)	0.0
No	Ramp XSlope (%)	3.4			
N/A	Flare Type LT	N/A	N/A	Flare Type RT	N/A
N/A	Flare Slope LT (%)	N/A	N/A	Flare Slope RT (%)	0.0
N/A	Flare Traversable LT?	N/A	N/A	Flare Traversable RT?	N/A
N/A	Landing Length (in)	0.0	N/A	DWS Provided?	N/A
N/A	Landing Width (in)	0.0	N/A	DWS Contrast?	N/A
N/A	Landing Slope (%)	0.0	N/A	DWS Length (in)	N/A
N/A	Landing X Slope (%)	0.0	N/A	DWS Full Width?	N/A
N/A	Landing Curb? (Y/N)	N/A	N/A	DWS Offset LT (in)	N/A
N/A	Shared Landing?	N/A	N/A	DWS Offset RT (in)	N/A
N/A	Gutter Ponding?	0.0	N/A	Gutter Slope (%)	N/A
N/A	Gutter Lip Ht (in)	0.0	N/A	Gutter X Slope (%)	N/A
N/A	Painted X Walk1?	No		Road Slope (%)	0.9
	X Walk 1 Direction	To N		Road X Slope (%)	1.4
	X Walk 1 Width (in)	N/A		Clear Space?	N/A

X Walk 1 Slope (%)	0.9	N/A	Clear Space to XWalk (in)	N/A
	X Walk 1 X Slope (%)	1.4	N/A	Storm Grate/Utility Hazard?	N/A
N/A	Ramp inside XWalk1?	N/A		Storm Grate/Utility Type	
N/A	Any Obstructions?	N/A			N/A
	Obstruction Type		Yes	Surface Condition? (G/P)	Good
			N/A	Curb Slope (%)	15.2

Remove & Replace Entire Ramp.

Total Cost: \$ 1600.00
