# Access Compliance Report

## Public Rights-of-Way

Intersection ID: 10572	Main Street: GRIMES_ST	Cross Street: SYLVANIA_AV	Location: S
ADA ID: 2DA3F708C825	Ramp Type: Perp	Initial Pass/Fail: Fail	Overall Compliance: No
			Severity Score: 21.25

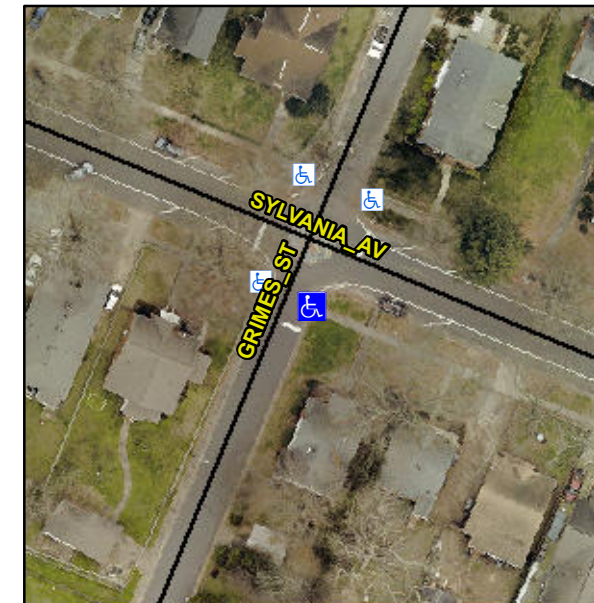
**Not Found, R304.5.1, R304.2.2**

Compliance	Description	Data	Compliance	Description	Data
N/A	Ramp Length (in)	52.5	No	Ramp Slope (%)	11.2
No	Ramp Width (in)	46.5	Yes	Ramp XSlope (%)	2.0
N/A	Flare Type LT	N/A	N/A	Flare Type RT	N/A
N/A	Flare Slope LT (%)	N/A	N/A	Flare Slope RT (%)	N/A
N/A	Flare Traversable LT?	N/A	N/A	Flare Traversable RT?	N/A
N/A	Landing Length (in)	N/A	N/A	DWS Provided?	N/A
N/A	Landing Width (in)	N/A	N/A	DWS Contrast?	N/A
N/A	Landing Slope (%)	N/A	N/A	DWS Length (in)	N/A
N/A	Landing X Slope (%)	N/A	N/A	DWS Full Width?	N/A
N/A	Landing Curb? (Y/N)	N/A	N/A	DWS Offset (in)	N/A
N/A	Shared Landing?	N/A			
N/A	Gutter Ponding?	N/A	N/A	Gutter Slope (%)	N/A
N/A	Gutter Lip Ht (in)	1.0	N/A	Gutter X Slope (%)	N/A
N/A	Painted X Walk1?	No	N/A	Painted X Walk2?	N/A
	X Walk 1 Direction	To NW		X Walk 2 Direction	N/A
N/A	X Walk 1 Width (in)	N/A	N/A	X Walk 2 Width (in)	N/A
	X Walk 1 Slope (%)	2.3		X Walk 2 Slope (%)	N/A
	X Walk 1 X Slope (%)	1.2		X Walk 2 X Slope (%)	N/A

N/A	Ramp inside XWalk1?	N/A	N/A	Ramp inside XWalk2?	N/A
	Road Slope (%)	N/A	N/A	Clear Space?	N/A
	Road X Slope (%)	N/A	N/A	Clear Space to XWalk (in)	N/A
N/A	Any Obstructions?	N/A	N/A	Storm Grate/Utility Hazard?	N/A
	Obstruction Type			Storm Grate/Utility Type	
		N/A			N/A
			Yes	Surface Condition? (G/P)	Good

**Remove & Replace Entire Ramp.**

Total Cost: \$ 1850.00
