# Access Compliance Report

## Public Rights-of-Way

### (Curb Ramps)

Intersection ID: 24592	Main Street: GREYABBY_CT	Cross Street: MALLOW_PL	Location: SW
ADA ID: 2DB244ADF346	Ramp Type: PerpDiag	Initial Pass/Fail: Fail	Overall Compliance: No
Severity Score: 13.75			
Codes/Mitigation Info/Possible Solution		Field Measurements/Component Compliance

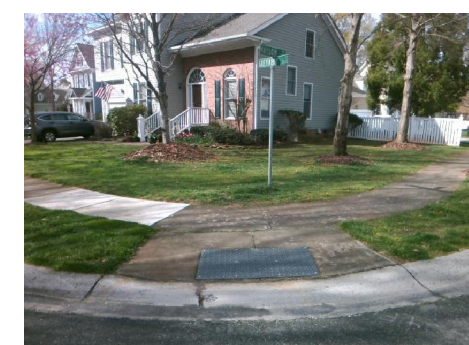
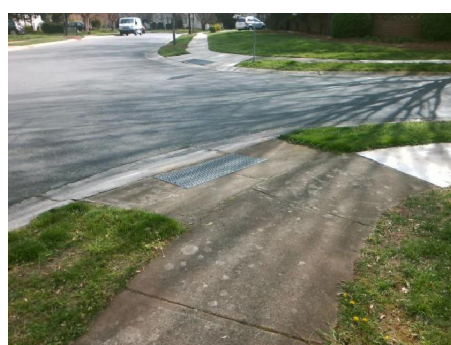
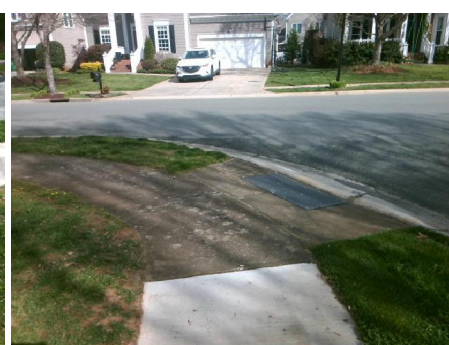
**Not Found, R304.2.2, R304.5.3**

Compliance	Description	Data	Compliance	Description	Data
N/A	Ramp Length (in)	46.0	No	Ramp Slope (%)	11.3
Yes	Ramp Width (in)	48.0	No	Ramp XSlope (%)	2.5
N/A	Flare Type LT	N/A	N/A	Flare Type RT	N/A
N/A	Flare Slope LT (%)	N/A	N/A	Flare Slope RT (%)	N/A
N/A	Flare Traversable LT?	N/A	N/A	Flare Traversable RT?	N/A
N/A	Landing Length (in)	N/A	N/A	DWS Provided?	N/A
N/A	Landing Width (in)	N/A	N/A	DWS Contrast?	N/A
N/A	Landing Slope (%)	N/A	N/A	DWS Length (in)	N/A
N/A	Landing X Slope (%)	N/A	N/A	DWS Full Width?	N/A
N/A	Landing Curb? (Y/N)	N/A	N/A	DWS Offset (in)	N/A
N/A	Shared Landing?	N/A			
N/A	Gutter Ponding?	N/A	N/A	Gutter Slope (%)	N/A
N/A	Gutter Lip Ht (in)	N/A	N/A	Gutter X Slope (%)	N/A
N/A	Painted X Walk1?	No	N/A	Painted X Walk2?	No
	X Walk 1 Direction	To E		X Walk 2 Direction	To N
N/A	X Walk 1 Width (in)	N/A	N/A	X Walk 2 Width (in)	N/A
	X Walk 1 Slope (%)	2.5		X Walk 2 Slope (%)	3.7
	X Walk 1 X Slope (%)	1.9		X Walk 2 X Slope (%)	0.3

N/A	Ramp inside XWalk1?	N/A	N/A	Ramp inside XWalk2?	N/A
	Road Slope (%)	0.8	N/A	Clear Space?	N/A
	Road X Slope (%)	5.3	N/A	Clear Space to XWalk (in)	N/A
N/A	Any Obstructions?	N/A	N/A	Storm Grate/Utility Hazard?	N/A
	Obstruction Type			Storm Grate/Utility Type	
		N/A			N/A
			Yes	Surface Condition? (G/P)	Good

**Remove & Replace Curb Ramp With Two New Directional Ramps or Equivalent.**
