Access Compliance Report Public Rights-of-Way (Curb Ramps)

Intersection ID: 10037122 Main Street: SALEM DR Cross Street: N/A Location: SE Initial Pass/Fail: Fail **Overall Compliance: No Severity Score:** 22.5 ADA ID: 2DB3975D8618 Ramp Type: PerpDiag

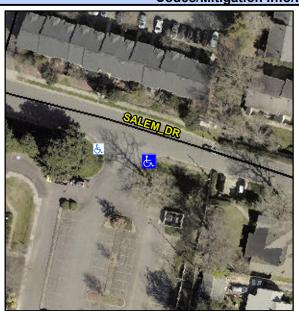
11.4

3.0

Ramp Slope (%)

Ramp XSlope (%)

Street 1 Name SALEM DR Stop Condition-Street 2 None **ENTRANCE** Street 2 Name Stop Condition-Street 1 None Possible Solutions: Remove & Replace Curb Ramp With Two New Directional Ramps or Equivalent. Surveyor Notes: N/A PROW/ADA: Not Found, R304.5.1, R304.2.2, R304.5.3
