## **Access Compliance Report Public Rights-of-Way** (Curb Ramps)

Intersection ID: 27766 Main Street: BLAKENEY\_HEATH\_RD Cross Street: BRYANT\_FARMS\_RD Location: Severity Score: **Overall Compliance: No ADA ID: 2DB6F96DB712** Ramp Type: Directional1 Initial Pass/Fail: Fail 1.25

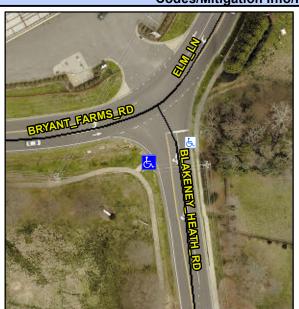
Field Measurements/Component Compliance									
Compli	iance	Description	Data	Com	pliance	Description	Data		
N/A	Ramp	Length (in)	47.0	N/A	Grad	e Break?	N/A		
Yes	Ramp	Width (in)	57.0	N/A	Grad	e Break Slope (%)	0.0		
Yes	Ramp	Slope (%)	5.1	N/A	Grad	e Break XSlope (%)	0.0		
No	Ramp	XSlope (%)	4.5						
N/A	Flare	Type LT	N/A	N/A	Flare	Type RT	N/A		
N/A	Flare	Slope LT (%)	N/A	N/A	Flare	Slope RT (%)	0.0		
N/A	Flare	Traversable LT?	N/A	N/A	Flare	Traversable RT?	N/A		
N/A	Landi	ng Length (in)	0.0	N/A	DWS	Provided?	N/A		
N/A	Landi	ng Width (in)	0.0	N/A	DWS	Contrast?	N/A		
N/A	Landi	ng Slope (%)	0.0	N/A	DWS	Length (in)	N/A		
N/A	Landi	ng X Slope (%)	0.0	N/A	DWS	Full Width?	N/A		
N/A	Landi	ng Curb? (Y/N)	N/A	N/A	DWS	Offset LT (in)	N/A		
N/A	Share	ed Landing?	N/A	N/A	DWS	Offset RT (in)	N/A		
N/A	Gutte	r Ponding?	0.0	N/A	Gutte	er Slope (%)	N/A		
N/A	Gutte	r Lip Ht (in)	0.0	N/A	Gutte	er X Slope (%)	N/A		
N/A	Painte	ed X Walk1?	No		Road	l Slope (%)	1.9

X Wal	k 1 Direction	To NE		Road	I X Slope (%)	6.4		
	X Wal	k 1 Width (in)	N/A		Clea	r Space?	N/A		
	X Wal	k 1 Slope (%)	1.9	N/A	Clea	r Space to XWalk (in)	N/A		
	X Wal	k 1 X Slope (%)	6.4	N/A	Storr	n Grate/Utility Hazard?	N/A		
N/A	Ramp	inside XWalk1?	N/A		Storr	n Grate/Utility Type			
N/A	Any C	bstructions?	N/A				N/A		
	Obstr	uction Type		Yes	Surfa	ace Condition? (G/P)	Good		
			N/A	N/A	Curb	Slope (%)	0.6

Possible Solutions:	
Remove & Replace Entire Ramp.	
Surveyor Notes:	
N/A	
PROW/ADA:	
R304.5.3	
1004.5.5

R304.5.3	
Total Cost:	\$ 1600.00
