Access Compliance Report Public Rights-of-Way (Curb Ramps)

/
Intersection ID: 10560	Main Street: ANDERSON_ST			Street:	TAPPAN_PL	Location:	w		
ADA ID: 2DB901733883	Ramp Type: Perp			Initial Pass/Fail: Fail Overall Compliance: N				o Severity Score:	10
Codes/Mitigation Info/Possible Solution				Field Measurements/Component Compliance					
		Possible Solutions:					Data Compliance Description

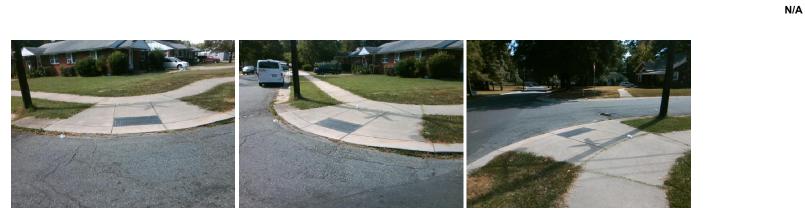
- 18 May 16	Remove & Replace Entire Ramp	_	N/A	Ramp Length (in)	78.5	Yes	Ramp Slope (%)	6.7
	No Company		-	No	Ramp Width (in)	47.0	No	Ramp XSlope (%)	3.2
	ALL ALL			N/A	Flare Type LT	N/A	N/A	Flare Type RT	N/A
				N/A	Flare Slope LT (%)	N/A	N/A	Flare Slope RT (%)	N/A
A B	1 1 2 3 9			N/A	Flare Traversable LT?	N/A	N/A	Flare Traversable RT?	N/A
The second	Las Las Ma			N/A	Landing Length (in)	N/A	N/A	DWS Provided?	N/A
a correction	ANT CAL	Surveyor Notes:		N/A	Landing Width (in)	N/A	N/A	DWS Contrast?	N/A
E T	and the stat	N/A		N/A	Landing Slope (%)	N/A	N/A	DWS Length (in)	N/A
1 1 1 1 1 1 to	NOT A COM			N/A	Landing X Slope (%)	N/A	N/A	DWS Full Width?	N/A
				N/A	Landing Curb? (Y/N)	N/A	N/A	DWS Offset (in)	N/A
SI /	and the second			N/A	Shared Landing?	N/A			
		PROW/ADA:		N/A	Gutter Ponding?	N/A	N/A	Gutter Slope (%)	N/A
		Not Found, R304.5.1, R304.5.3		N/A	Gutter Lip Ht (in)	1.0	N/A	Gutter X Slope (%)	N/A
	1 x 1 x			N/A	Painted X Walk1?	No	N/A	Painted X Walk2?	N/A

A PARA				X Walk 1 Direction	To SE		X Walk 2 Direction	N/A
				N/A	X Walk 1 Width (in)	N/A	N/A	X Walk 2 Width (in)	N/A
Street 1 Name	TAPPAN PL	-			X Walk 1 Slope (%)	3.0		X Walk 2 Slope (%)	N/A
Stop Condition-Street 2	StopSign				X Walk 1 X Slope (%)	0.8		X Walk 2 X Slope (%)	N/A
Street 2 Name	N/A			N/A	Ramp inside XWalk1?	N/A	N/A	Ramp inside XWalk2?	N/A
Stop Condition-Street 1	N/A				Road Slope (%)	N/A	N/A	Clear Space?	N/A
,					Road X Slope (%)	N/A	N/A	Clear Space to XWalk (in)	N/A
				N/A	Any Obstructions?	N/A	N/A	Storm Grate/Utility Hazard?	N/A
		Total Cost: \$	1850.00		Obstruction Type			Storm Grate/Utility Type	
		·			<i>,</i> ,,,,,,,,,,,,,,,,,,,,,,,,,,,,,,,,,,,	N/A			N/A
