Access Compliance Report

Public Rights-of-Way

(Curb Ramps)

Intersection ID: 27707	Main Street: CREEK_BERRY_DR	Cross Street: HAMPSHIRE_HILL_RD	Location: NE
ADA ID: 2DBCDFE9DD64	Ramp Type: BlendTrans1	Initial Pass/Fail: Pass	Overall Compliance: No
Severity Score: 0			
Codes/Mitigation Info/Possible Solution		Field Measurements/Component Compliance

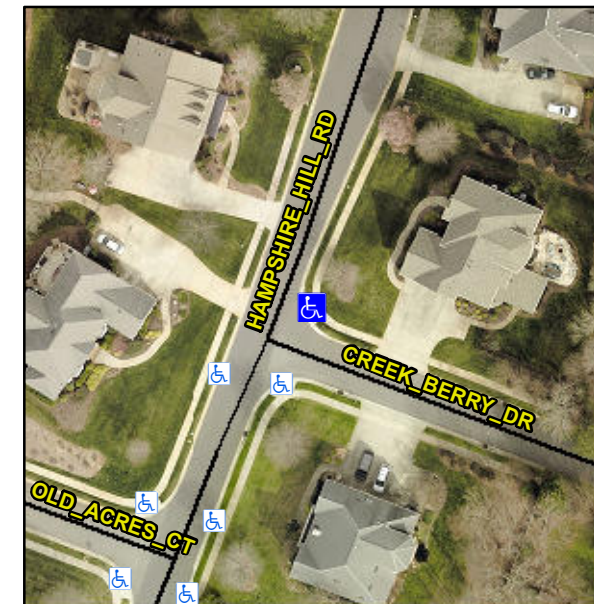
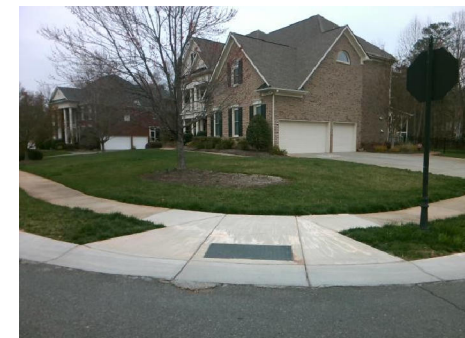
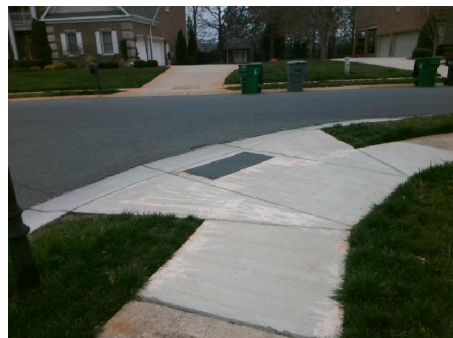
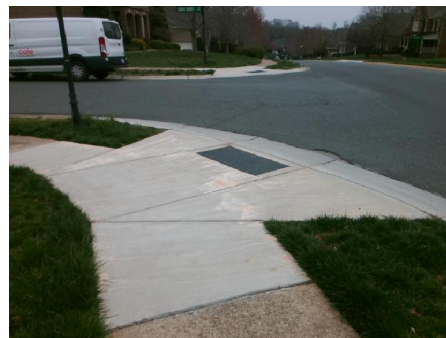
Compliance	Description	Data	Compliance	Description	Data
N/A	Ramp Length (in)	54.5	Yes	BlendTrans Slope (%)	3.0
Yes	Ramp Width (in)	57.0	Yes	BlendTrans XSlope (%)	1.6
N/A	Flare Type LT	Sloped	N/A	Flare Type RT	Sloped
N/A	Flare Slope LT (%)	5.0	N/A	Flare Slope RT (%)	4.0
N/A	Flare Traversable LT?	No	N/A	Flare Traversable RT?	No
Yes	Landing Length (in)	52.0	Yes	DWS Provided?	Yes
Yes	Landing Width (in)	57.0	Yes	DWS Contrast?	Yes
No	Landing Slope (%)	2.5	Yes	DWS Length (in)	24.0
Yes	Landing X Slope (%)	1.7	Yes	DWS Full Width?	Yes
N/A	Landing Curb? (Y/N)	No	No	DWS Offset (in)	6.5
N/A	Shared Landing?	No			
Yes	Gutter Ponding?	No	Yes	Gutter Slope (%)	0.4
Yes	Gutter Lip Ht (in)	0.0	No	Gutter X Slope (%)	2.5
N/A	Painted X Walk1?	No	N/A	Painted X Walk2?	No
	X Walk 1 Direction	To W		X Walk 2 Direction	To SW
	X Walk 1 Width (in)	N/A		X Walk 2 Width (in)	N/A
	X Walk 1 Slope (%)	2.6		X Walk 2 Slope (%)	0.8
	X Walk 1 X Slope (%)	1.3		X Walk 2 X Slope (%)	2.1

N/A	Ramp inside XWalk1?	N/A	N/A	Ramp inside XWalk2?	N/A
	Road Slope (%)	2.8		Clear Space?	Yes
	Road X Slope (%)	3.4	N/A	Clear Space to XWalk (in)	N/A
Yes	Any Obstructions?	No	Yes	Storm Grate/Utility Hazard?	No
	Obstruction Type			Storm Grate/Utility Type	
		N/A			N/A
			Yes	Surface Condition? (G/P)	Good
			No	Curb Slope (%)	5.5

Possible Solutions:

Remove & Replace Curb Ramp With Two New Directional Ramps or Equivalent. Remove & Replace Gutter.
