# Access Compliance Report

## Public Rights-of-Way

### (Curb Ramps)

Intersection ID: 20969	Main Street: OLD_REID_RD	Cross Street: PARK_RD	Location: NW
ADA ID: 2DC7C82A90E1	Ramp Type: BlendTrans2	Initial Pass/Fail: Fail	Overall Compliance: No
		Severity Score: 40

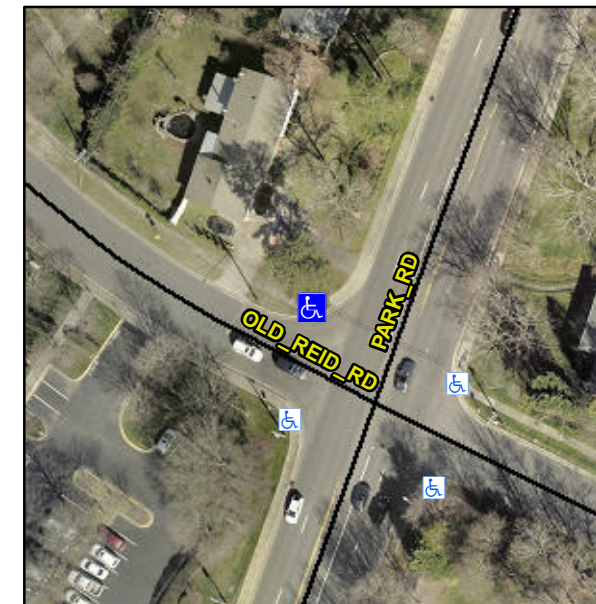
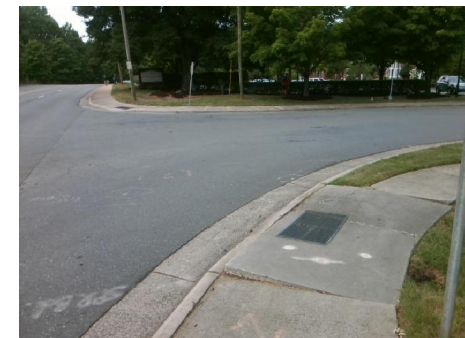
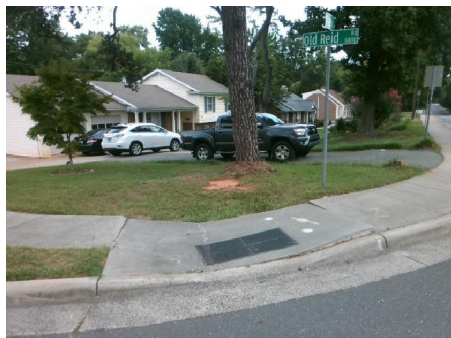
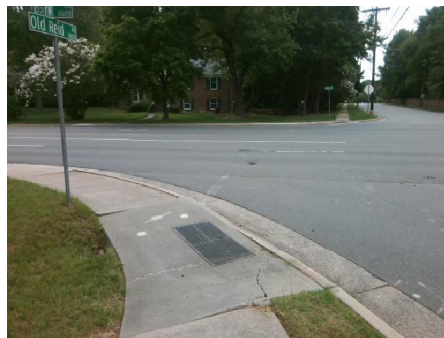
Compliance	Description	Data	Compliance	Description	Data
N/A	Ramp Length (in)	64.0	Yes	BlendTrans Slope (%)	0.6
Yes	Ramp Width (in)	48.0	No	BlendTrans XSlope (%)	12.6
N/A	Flare Type LT	N/A	N/A	Flare Type RT	N/A
N/A	Flare Slope LT (%)	N/A	N/A	Flare Slope RT (%)	N/A
N/A	Flare Traversable LT?	N/A	N/A	Flare Traversable RT?	N/A
N/A	Landing Length (in)	N/A	N/A	DWS Provided?	N/A
N/A	Landing Width (in)	N/A	N/A	DWS Contrast?	N/A
N/A	Landing Slope (%)	N/A	N/A	DWS Length (in)	N/A
N/A	Landing X Slope (%)	N/A	N/A	DWS Full Width?	N/A
N/A	Landing Curb? (Y/N)	N/A	N/A	DWS Offset (in)	N/A
N/A	Shared Landing?	N/A			
N/A	Gutter Ponding?	N/A	N/A	Gutter Slope (%)	N/A
N/A	Gutter Lip Ht (in)	N/A	N/A	Gutter X Slope (%)	N/A
N/A	Painted X Walk1?	No	N/A	Painted X Walk2?	No
	X Walk 1 Direction	To S		X Walk 2 Direction	To SE
	X Walk 1 Width (in)	N/A		X Walk 2 Width (in)	N/A
	X Walk 1 Slope (%)	0.8		X Walk 2 Slope (%)	5.1
	X Walk 1 X Slope (%)	4.5		X Walk 2 X Slope (%)	1.1

N/A	Ramp inside XWalk1?	N/A	N/A	Ramp inside XWalk2?	N/A
	Road Slope (%)	4.1		Clear Space?	N/A
	Road X Slope (%)	3.6	N/A	Clear Space to XWalk (in)	N/A
N/A	Any Obstructions?	N/A	N/A	Storm Grate/Utility Hazard?	N/A
	Obstruction Type			Storm Grate/Utility Type	
		N/A			N/A
		No		Surface Condition? (G/P)	Poor
		No		Curb Slope (%)	21.1

**Remove & Replace Curb Ramp With Two New Directional Ramps or Equivalent.**

**Not Found, R304.5.3, R302.7**
