# Access Compliance Report

## Public Rights-of-Way

### (Curb Ramps)

Intersection ID: 10024504	Main Street: CRUMP_RD	Cross Street: N/A	Location: SW
ADA ID: 2DD21B7517CC	Ramp Type: Perp	Initial Pass/Fail: Fail	Overall Compliance: No
Codes/Mitigation Info/Possible Solution		Field Measurements/Component Compliance	
Severity Score: 12.5

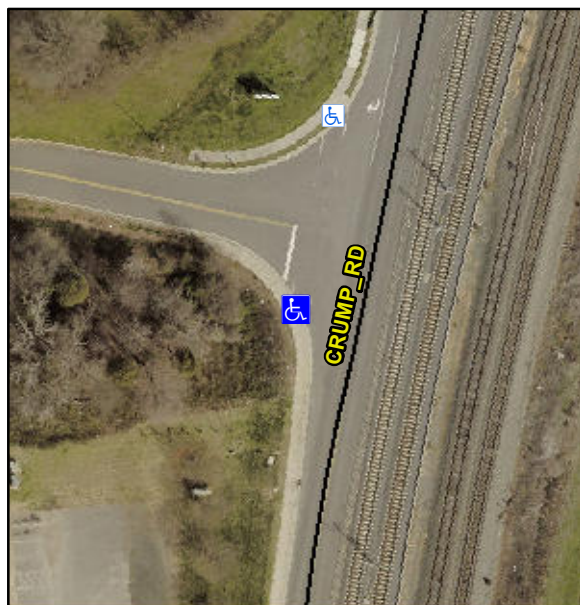
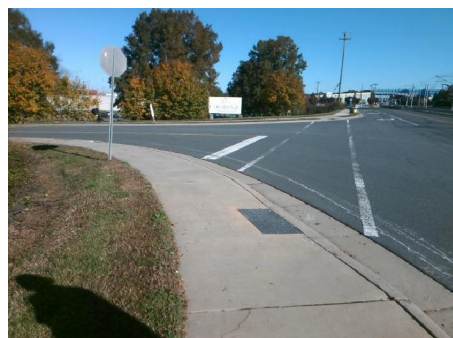
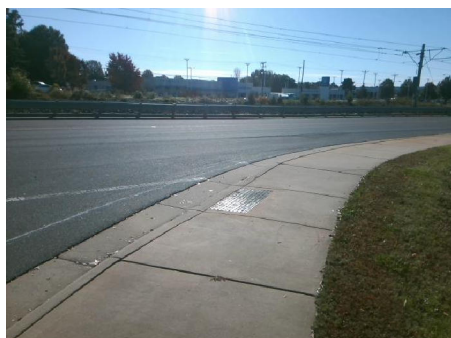
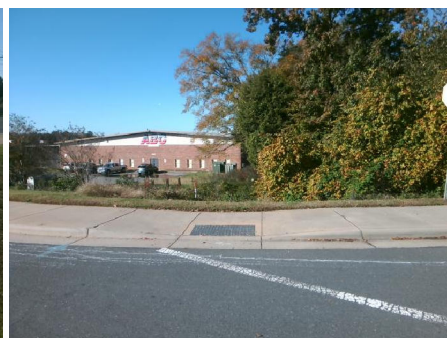
**Not Found, R304.2.2**

Compliance	Description	Data	Compliance	Description	Data
N/A	Ramp Length (in)	72.0	No	Ramp Slope (%)	8.4
Yes	Ramp Width (in)	57.0	Yes	Ramp XSlope (%)	0.8
N/A	Flare Type LT	N/A	N/A	Flare Type RT	N/A
N/A	Flare Slope LT (%)	N/A	N/A	Flare Slope RT (%)	N/A
N/A	Flare Traversable LT?	N/A	N/A	Flare Traversable RT?	N/A
N/A	Landing Length (in)	N/A	N/A	DWS Provided?	N/A
N/A	Landing Width (in)	N/A	N/A	DWS Contrast?	N/A
N/A	Landing Slope (%)	N/A	N/A	DWS Length (in)	N/A
N/A	Landing X Slope (%)	N/A	N/A	DWS Full Width?	N/A
N/A	Landing Curb? (Y/N)	N/A	N/A	DWS Offset (in)	N/A
N/A	Shared Landing?	N/A			
N/A	Gutter Ponding?	N/A	N/A	Gutter Slope (%)	N/A
N/A	Gutter Lip Ht (in)	N/A	N/A	Gutter X Slope (%)	N/A
N/A	Painted X Walk1?	Yes	N/A	Painted X Walk2?	N/A
	X Walk 1 Direction	To NE		X Walk 2 Direction	N/A
N/A	X Walk 1 Width (in)	112.0	N/A	X Walk 2 Width (in)	N/A
	X Walk 1 Slope (%)	0.0		X Walk 2 Slope (%)	N/A
	X Walk 1 X Slope (%)	3.4		X Walk 2 X Slope (%)	N/A

N/A	Ramp inside XWalk1?	Yes	N/A	Ramp inside XWalk2?	N/A
	Road Slope (%)	N/A	N/A	Clear Space?	N/A
	Road X Slope (%)	N/A	N/A	Clear Space to XWalk (in)	N/A
N/A	Any Obstructions?	N/A	N/A	Storm Grate/Utility Hazard?	N/A
	Obstruction Type			Storm Grate/Utility Type	
		N/A			N/A
			Yes	Surface Condition? (G/P)	Good

**Remove & Replace Entire Ramp.**
