# Access Compliance Report

## Public Rights-of-Way

### (Curb Ramps)

Intersection ID: 50344	Main Street: KELBURN_LN	Cross Street: FENWAY_DR	Location: NE
ADA ID: 2DD60EDE9391	Ramp Type: Perp	Initial Pass/Fail: Fail	Overall Compliance: No
Codes/Mitigation Info/Possible Solution			Severity Score: 10
			Field Measurements/Component Compliance

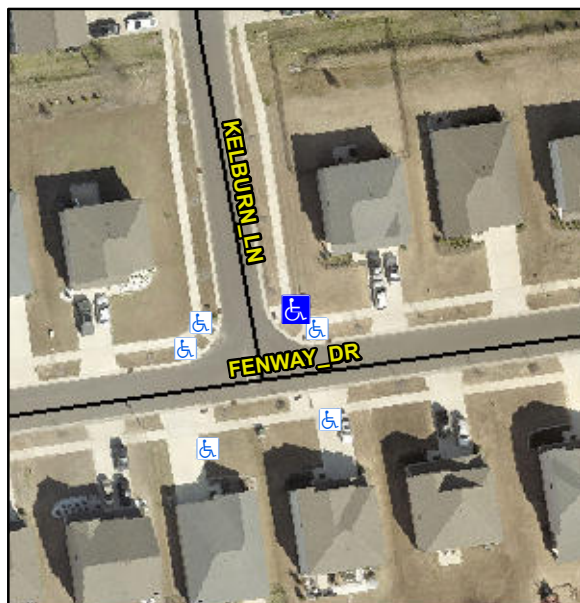
**Not Found, R304.5.1, R304.5.3**

Compliance	Description	Data	Compliance	Description	Data
N/A	Ramp Length (in)	97.0	Yes	Ramp Slope (%)	8.1
No	Ramp Width (in)	47.5	No	Ramp XSlope (%)	2.3
N/A	Flare Type LT	N/A	N/A	Flare Type RT	N/A
N/A	Flare Slope LT (%)	N/A	N/A	Flare Slope RT (%)	N/A
N/A	Flare Traversable LT?	N/A	N/A	Flare Traversable RT?	N/A
N/A	Landing Length (in)	N/A	N/A	DWS Provided?	N/A
N/A	Landing Width (in)	N/A	N/A	DWS Contrast?	N/A
N/A	Landing Slope (%)	N/A	N/A	DWS Length (in)	N/A
N/A	Landing X Slope (%)	N/A	N/A	DWS Full Width?	N/A
N/A	Landing Curb? (Y/N)	N/A	N/A	DWS Offset (in)	N/A
N/A	Shared Landing?	N/A			
N/A	Gutter Ponding?	N/A	N/A	Gutter Slope (%)	N/A
N/A	Gutter Lip Ht (in)	1.0	N/A	Gutter X Slope (%)	N/A
N/A	Painted X Walk1?	No	N/A	Painted X Walk2?	N/A
	X Walk 1 Direction	To W		X Walk 2 Direction	N/A
N/A	X Walk 1 Width (in)	N/A	N/A	X Walk 2 Width (in)	N/A
	X Walk 1 Slope (%)	1.4		X Walk 2 Slope (%)	N/A
	X Walk 1 X Slope (%)	3.3		X Walk 2 X Slope (%)	N/A

N/A	Ramp inside XWalk1?	N/A	N/A	Ramp inside XWalk2?	N/A
	Road Slope (%)	N/A	N/A	Clear Space?	N/A
	Road X Slope (%)	N/A	N/A	Clear Space to XWalk (in)	N/A
N/A	Any Obstructions?	N/A	N/A	Storm Grate/Utility Hazard?	N/A
	Obstruction Type			Storm Grate/Utility Type	
		N/A			N/A
			Yes	Surface Condition? (G/P)	Good

**Remove & Replace Entire Ramp.**
