Access Compliance Report

Public Rights-of-Way (Curb Ramps)

Intersection ID: N/A	Main Street: AGNEW_DR	Cross Street: SOLAR_WY	Location: NE
ADA ID: 2DD9318AA65B	Ramp Type: Perp	Initial Pass/Fail: Fail	Overall Compliance: No
		Severity Score: 37.5

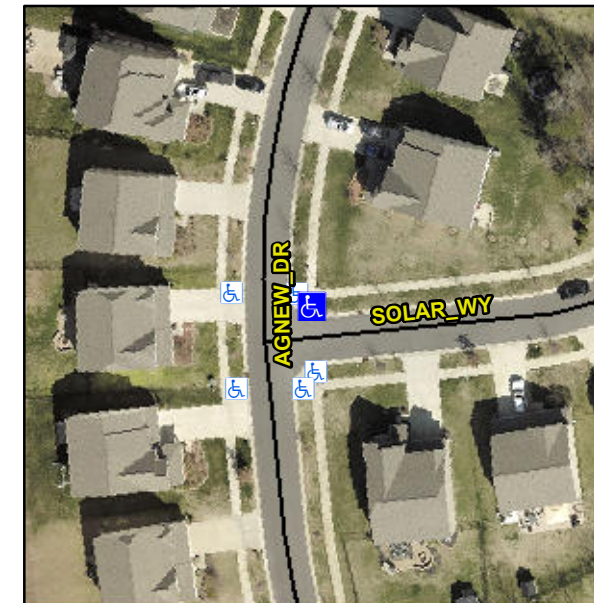
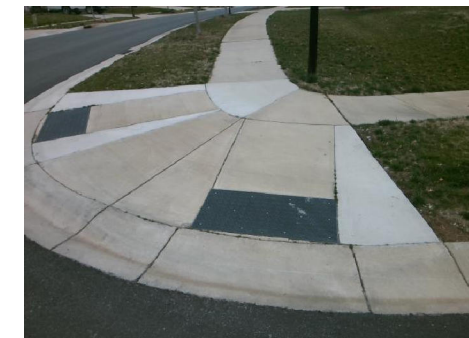
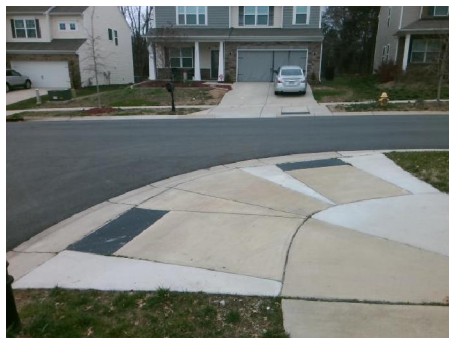
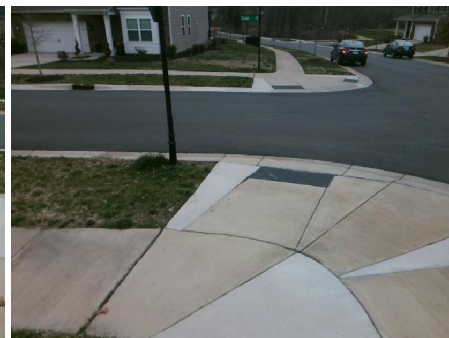
Not Found, R304.2.2, R304.5.3

Compliance	Description	Data	Compliance	Description	Data
N/A	Ramp Length (in)	96.0	No	Ramp Slope (%)	9.8
Yes	Ramp Width (in)	48.0	No	Ramp XSlope (%)	8.5
N/A	Flare Type LT	N/A	N/A	Flare Type RT	N/A
N/A	Flare Slope LT (%)	N/A	N/A	Flare Slope RT (%)	N/A
N/A	Flare Traversable LT?	N/A	N/A	Flare Traversable RT?	N/A
N/A	Landing Length (in)	N/A	N/A	DWS Provided?	N/A
N/A	Landing Width (in)	N/A	N/A	DWS Contrast?	N/A
N/A	Landing Slope (%)	N/A	N/A	DWS Length (in)	N/A
N/A	Landing X Slope (%)	N/A	N/A	DWS Full Width?	N/A
N/A	Landing Curb? (Y/N)	N/A	N/A	DWS Offset (in)	N/A
N/A	Shared Landing?	N/A			
N/A	Gutter Ponding?	N/A	N/A	Gutter Slope (%)	N/A
N/A	Gutter Lip Ht (in)	N/A	N/A	Gutter X Slope (%)	N/A
N/A	Painted X Walk1?	No	N/A	Painted X Walk2?	N/A
	X Walk 1 Direction	To S		X Walk 2 Direction	N/A
N/A	X Walk 1 Width (in)	N/A	N/A	X Walk 2 Width (in)	N/A
	X Walk 1 Slope (%)	1.8		X Walk 2 Slope (%)	N/A
	X Walk 1 X Slope (%)	3.6		X Walk 2 X Slope (%)	N/A

N/A	Ramp inside XWalk1?	N/A	N/A	Ramp inside XWalk2?	N/A
	Road Slope (%)	N/A	N/A	Clear Space?	N/A
	Road X Slope (%)	N/A	N/A	Clear Space to XWalk (in)	N/A
N/A	Any Obstructions?	N/A	N/A	Storm Grate/Utility Hazard?	N/A
	Obstruction Type			Storm Grate/Utility Type	
		N/A			N/A
			Yes	Surface Condition? (G/P)	Good

Remove & Replace Entire Ramp.
