# Access Compliance Report

## Public Rights-of-Way

### (Curb Ramps)

Intersection ID: 10030537	Main Street: LITTLE ROCK RD	Cross Street: N/A	Location:	N
ADA ID: 2DE3A5DA409A	Ramp Type: BlendTrans2	Initial Pass/Fail: Fail	Overall Compliance: No	Severity Score: 10

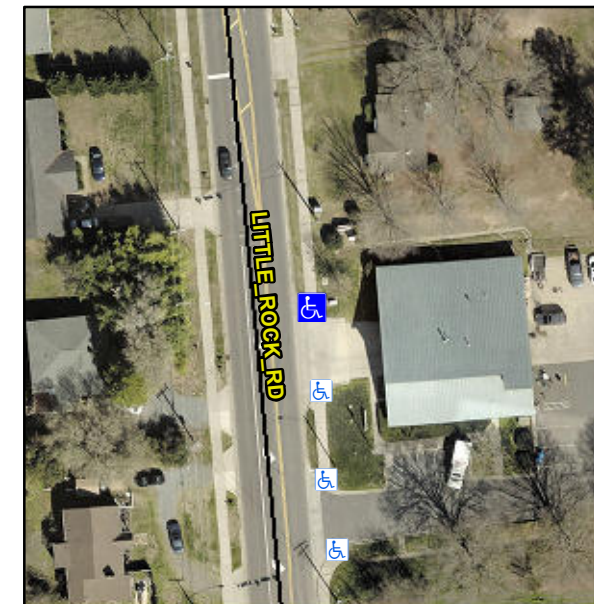
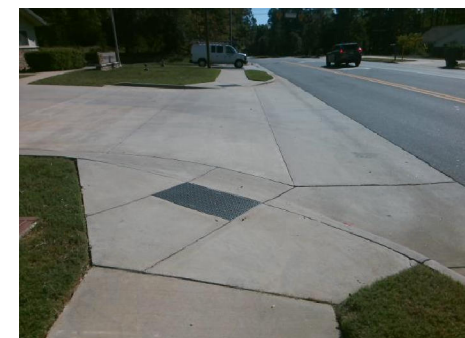
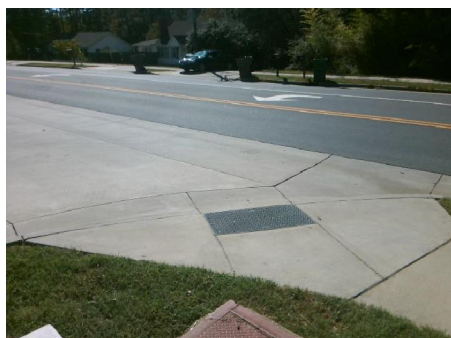
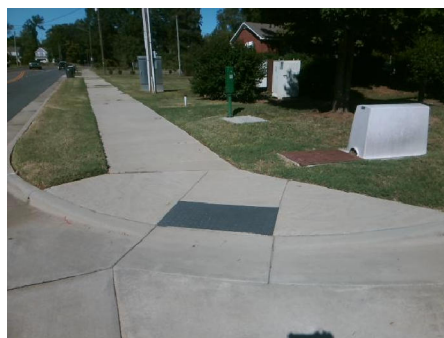
**Not Found, R304.5.1, R304.5.3**

Compliance	Description	Data	Compliance	Description	Data
N/A	Ramp Length (in)	75.0	Yes	BlendTrans Slope (%)	4.5
No	Ramp Width (in)	47.0	No	BlendTrans XSlope (%)	2.6
N/A	Flare Type LT	N/A	N/A	Flare Type RT	N/A
N/A	Flare Slope LT (%)	N/A	N/A	Flare Slope RT (%)	N/A
N/A	Flare Traversable LT?	N/A	N/A	Flare Traversable RT?	N/A
N/A	Landing Length (in)	N/A	N/A	DWS Provided?	N/A
N/A	Landing Width (in)	N/A	N/A	DWS Contrast?	N/A
N/A	Landing Slope (%)	N/A	N/A	DWS Length (in)	N/A
N/A	Landing X Slope (%)	N/A	N/A	DWS Full Width?	N/A
N/A	Landing Curb? (Y/N)	N/A	N/A	DWS Offset (in)	N/A
N/A	Shared Landing?	N/A			
N/A	Gutter Ponding?	N/A	N/A	Gutter Slope (%)	N/A
N/A	Gutter Lip Ht (in)	N/A	N/A	Gutter X Slope (%)	N/A
N/A	Painted X Walk1?	No	N/A	Painted X Walk2?	No
	X Walk 1 Direction	To W		X Walk 2 Direction	To S
	X Walk 1 Width (in)	N/A		X Walk 2 Width (in)	N/A
	X Walk 1 Slope (%)	2.1		X Walk 2 Slope (%)	1.1
	X Walk 1 X Slope (%)	0.7		X Walk 2 X Slope (%)	3.5

N/A	Ramp inside XWalk1?	N/A	N/A	Ramp inside XWalk2?	N/A
	Road Slope (%)	0.8		Clear Space?	N/A
	Road X Slope (%)	2.7	N/A	Clear Space to XWalk (in)	N/A
N/A	Any Obstructions?	N/A	N/A	Storm Grate/Utility Hazard?	N/A
	Obstruction Type			Storm Grate/Utility Type	
		N/A			N/A
			Yes	Surface Condition? (G/P)	Good
			No	Curb Slope (%)	7.4

**Remove & Replace Curb Ramp With Two New Directional Ramps or Equivalent.**
