Access Compliance Report

Public Rights-of-Way

(Curb Ramps)

Intersection ID: N/A	Main Street: ELEVATION_POINT_DR	Cross Street: FLOURNOY_DR	Location: NW
ADA ID: 2DEC74A1CAB7	Ramp Type: Perp	Initial Pass/Fail: Fail	Overall Compliance: No
Severity Score: 12.5			
Codes/Mitigation Info/Possible Solution		Field Measurements/Component Compliance

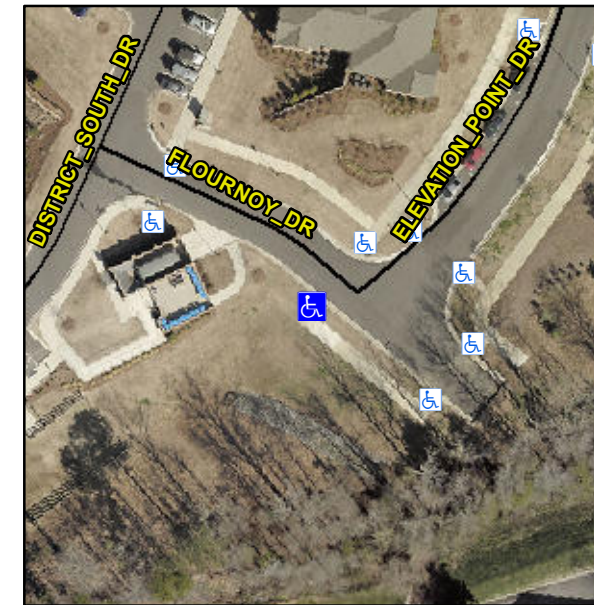
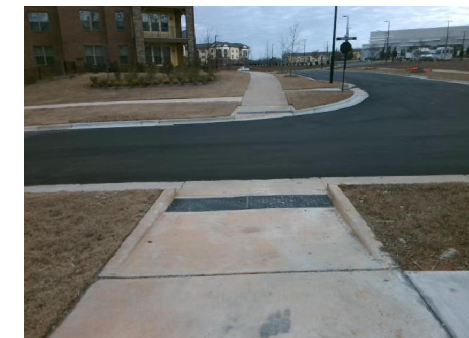
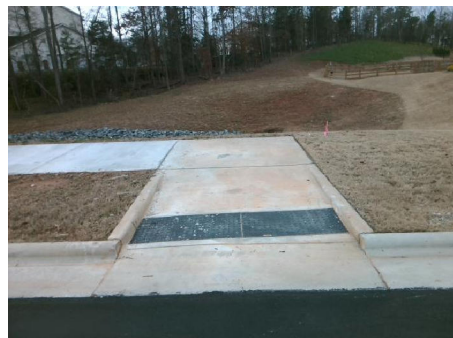
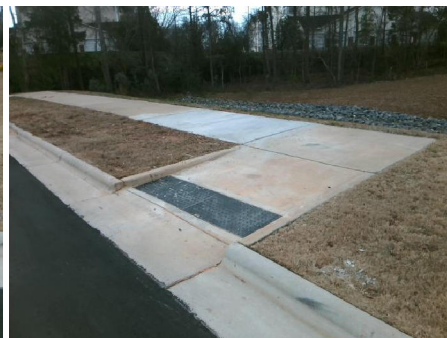
Not Found, R304.2.2

Compliance	Description	Data	Compliance	Description	Data
N/A	Ramp Length (in)	96.0	No	Ramp Slope (%)	9.5
Yes	Ramp Width (in)	94.0	Yes	Ramp XSlope (%)	2.0
N/A	Flare Type LT	N/A	N/A	Flare Type RT	N/A
N/A	Flare Slope LT (%)	N/A	N/A	Flare Slope RT (%)	N/A
N/A	Flare Traversable LT?	N/A	N/A	Flare Traversable RT?	N/A
N/A	Landing Length (in)	N/A	N/A	DWS Provided?	N/A
N/A	Landing Width (in)	N/A	N/A	DWS Contrast?	N/A
N/A	Landing Slope (%)	N/A	N/A	DWS Length (in)	N/A
N/A	Landing X Slope (%)	N/A	N/A	DWS Full Width?	N/A
N/A	Landing Curb? (Y/N)	N/A	N/A	DWS Offset (in)	N/A
N/A	Shared Landing?	N/A			
N/A	Gutter Ponding?	N/A	N/A	Gutter Slope (%)	N/A
N/A	Gutter Lip Ht (in)	N/A	N/A	Gutter X Slope (%)	N/A
N/A	Painted X Walk1?	No	N/A	Painted X Walk2?	N/A
	X Walk 1 Direction	To NE		X Walk 2 Direction	N/A
N/A	X Walk 1 Width (in)	N/A	N/A	X Walk 2 Width (in)	N/A
	X Walk 1 Slope (%)	0.8		X Walk 2 Slope (%)	N/A
	X Walk 1 X Slope (%)	3.0		X Walk 2 X Slope (%)	N/A

N/A	Ramp inside XWalk1?	N/A	N/A	Ramp inside XWalk2?	N/A
	Road Slope (%)	N/A	N/A	Clear Space?	N/A
	Road X Slope (%)	N/A	N/A	Clear Space to XWalk (in)	N/A
N/A	Any Obstructions?	N/A	N/A	Storm Grate/Utility Hazard?	N/A
	Obstruction Type			Storm Grate/Utility Type	
		N/A			N/A
			Yes	Surface Condition? (G/P)	Good

Possible Solutions:

Remove & Replace Entire Ramp.
