Access Compliance Report

Public Rights-of-Way

(Curb Ramps)

Intersection ID: 47820	Main Street: HERONS_POND_CT	Cross Street: ROYAL_FERN_LN	Location: NW
ADA ID: 2DF083F71CBE	Ramp Type: Perp	Initial Pass/Fail: Fail	Overall Compliance: No
Severity Score: 21.25			
Codes/Mitigation Info/Possible Solution		Field Measurements/Component Compliance

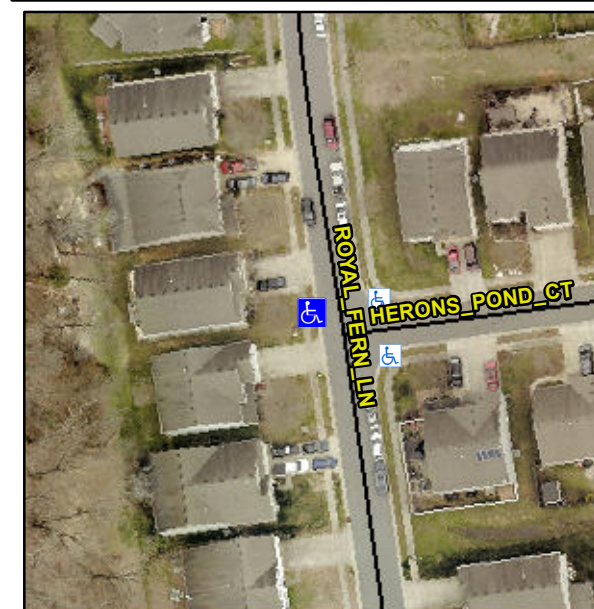
Not Found, R304.5.1, R304.5.3

Compliance	Description	Data	Compliance	Description	Data
N/A	Ramp Length (in)	49.0	Yes	Ramp Slope (%)	5.6
No	Ramp Width (in)	47.0	No	Ramp XSlope (%)	5.7
N/A	Flare Type LT	N/A	N/A	Flare Type RT	N/A
N/A	Flare Slope LT (%)	N/A	N/A	Flare Slope RT (%)	N/A
N/A	Flare Traversable LT?	N/A	N/A	Flare Traversable RT?	N/A
N/A	Landing Length (in)	N/A	N/A	DWS Provided?	N/A
N/A	Landing Width (in)	N/A	N/A	DWS Contrast?	N/A
N/A	Landing Slope (%)	N/A	N/A	DWS Length (in)	N/A
N/A	Landing X Slope (%)	N/A	N/A	DWS Full Width?	N/A
N/A	Landing Curb? (Y/N)	N/A	N/A	DWS Offset (in)	N/A
N/A	Shared Landing?	N/A			
N/A	Gutter Ponding?	N/A	N/A	Gutter Slope (%)	N/A
N/A	Gutter Lip Ht (in)	N/A	N/A	Gutter X Slope (%)	N/A
N/A	Painted X Walk1?	No	N/A	Painted X Walk2?	N/A
	X Walk 1 Direction	To E		X Walk 2 Direction	N/A
N/A	X Walk 1 Width (in)	N/A	N/A	X Walk 2 Width (in)	N/A
	X Walk 1 Slope (%)	2.6		X Walk 2 Slope (%)	N/A
	X Walk 1 X Slope (%)	6.4		X Walk 2 X Slope (%)	N/A

N/A	Ramp inside XWalk1?	N/A	N/A	Ramp inside XWalk2?	N/A
	Road Slope (%)	N/A	N/A	Clear Space?	N/A
	Road X Slope (%)	N/A	N/A	Clear Space to XWalk (in)	N/A
N/A	Any Obstructions?	N/A	N/A	Storm Grate/Utility Hazard?	N/A
	Obstruction Type			Storm Grate/Utility Type	
		N/A			N/A
			Yes	Surface Condition? (G/P)	Good

Possible Solutions:

Remove & Replace Entire Ramp.
