# Access Compliance Report

## Public Rights-of-Way

### (Curb Ramps)

| Intersection ID: 28029 | Main Street: BAY_HILL_CLUB_DR | Cross Street: PINE_VALLEY_CLUB_DR | Location: SE |

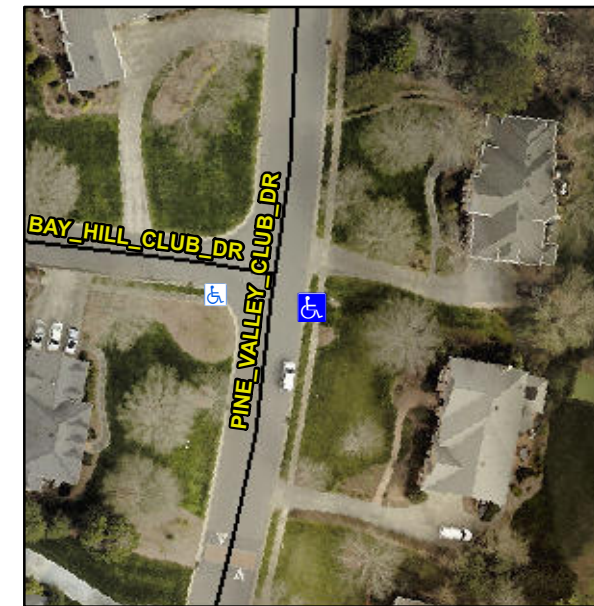
**Not Found, R304.2.2**

| Compliance | Description | Data | Compliance | Description | Data |
|---|---|---|---|---|---|
| N/A | Ramp Length (in) | 48.5 | No | Ramp Slope (%) | 8.4 |

**Remove & Replace Entire Ramp.**
