Access Compliance Report

Public Rights-of-Way

(Curb Ramps)

Intersection ID: 28238	Main Street: ADDINGTON_CT	Cross Street: DARBY_CHASE_DR	Location: NE
ADA ID: 2E0A2BCFE060	Ramp Type: Perp	Initial Pass/Fail: Fail	Overall Compliance: No
Severity Score: 1.25			
Codes/Mitigation Info/Possible Solution		Field Measurements/Component Compliance

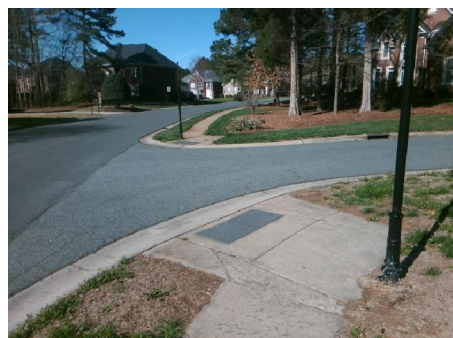
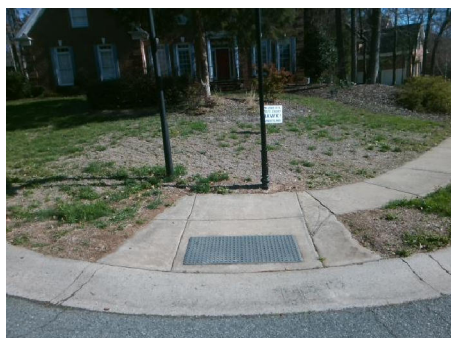
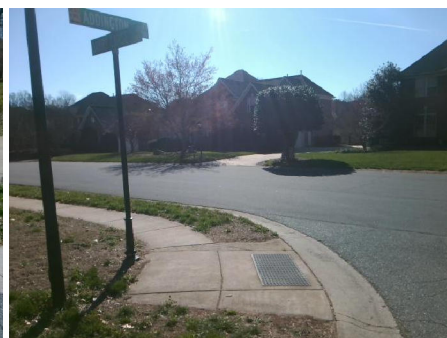
Compliance	Description	Data	Compliance	Description	Data
N/A	Ramp Length (in)	50.0	Yes	Ramp Slope (%)	6.5
Yes	Ramp Width (in)	61.5	No	Ramp XSlope (%)	4.7
N/A	Flare Type LT	N/A	N/A	Flare Type RT	N/A
N/A	Flare Slope LT (%)	N/A	N/A	Flare Slope RT (%)	N/A
N/A	Flare Traversable LT?	N/A	N/A	Flare Traversable RT?	N/A
N/A	Landing Length (in)	N/A	N/A	DWS Provided?	N/A
N/A	Landing Width (in)	N/A	N/A	DWS Contrast?	N/A
N/A	Landing Slope (%)	N/A	N/A	DWS Length (in)	N/A
N/A	Landing X Slope (%)	N/A	N/A	DWS Full Width?	N/A
N/A	Landing Curb? (Y/N)	N/A	N/A	DWS Offset (in)	N/A
N/A	Shared Landing?	N/A			
N/A	Gutter Ponding?	N/A	N/A	Gutter Slope (%)	N/A
N/A	Gutter Lip Ht (in)	N/A	N/A	Gutter X Slope (%)	N/A
N/A	Painted X Walk1?	No	N/A	Painted X Walk2?	N/A
	X Walk 1 Direction	To SW		X Walk 2 Direction	N/A
N/A	X Walk 1 Width (in)	N/A	N/A	X Walk 2 Width (in)	N/A
	X Walk 1 Slope (%)	1.6		X Walk 2 Slope (%)	N/A
	X Walk 1 X Slope (%)	3.2		X Walk 2 X Slope (%)	N/A

N/A	Ramp inside XWalk1?	N/A	N/A	Ramp inside XWalk2?	N/A
	Road Slope (%)	N/A	N/A	Clear Space?	N/A
	Road X Slope (%)	N/A	N/A	Clear Space to XWalk (in)	N/A
N/A	Any Obstructions?	N/A	N/A	Storm Grate/Utility Hazard?	N/A
	Obstruction Type			Storm Grate/Utility Type	
		N/A			N/A
		Yes		Surface Condition? (G/P)	Good

Possible Solutions:

Remove & Replace Entire Ramp.

Not Found, R304.5.3
