## Access Compliance Report Public Rights-of-Way (Curb Ramps)

Intersection ID: 44069 Main Street: WESTMILL\_LN Cross Street: KIRKWICH\_CT Location: E

ADA ID: 2E0EEFDB0A39 Ramp Type: BlendTrans1 Initial Pass/Fail: Fail Overall Compliance: No Severity Score: 18.75

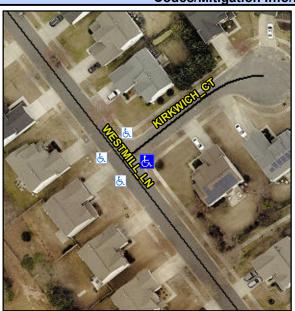
DAMAGED CURB/GTR

Not Found, R304.5.1, R304.5.3

Compliance Description Data Compliance Description Data Yes N/A Ramp Length (in) 72.0 BlendTrans Slope (%) 2.2 No No Ramp Width (in) 35.0 BlendTrans XSlope (%) 3.1 N/A N/A Flare Type LT N/A Flare Type RT N/A N/A Flare Slope LT (%) N/A N/A Flare Slope RT (%) N/A N/A Flare Traversable LT? N/A N/A Flare Traversable RT? N/A N/A N/A N/A **DWS Provided?** N/A Landing Length (in) N/A Landing Width (in) N/A N/A **DWS Contrast?** N/A N/A N/A N/A Landing Slope (%) DWS Length (in) N/A N/A Landing X Slope (%) N/A N/A DWS Full Width? N/A N/A Landing Curb? (Y/N) N/A N/A DWS Offset (in) N/A N/A N/A Shared Landing? N/A **Gutter Ponding?** N/A N/A Gutter Slope (%) N/A N/A Gutter Lip Ht (in) N/A N/A Gutter X Slope (%) N/A N/A Painted X Walk1? No N/A Painted X Walk2? No X Walk 1 Direction To NW X Walk 2 Direction To SW N/A X Walk 1 Width (in) X Walk 2 Width (in) N/A X Walk 1 Slope (%) 1.0 X Walk 2 Slope (%) 1.9 X Walk 1 X Slope (%) 0.4 X Walk 2 X Slope (%) 1.5 N/A N/A Ramp inside XWalk2? N/A N/A Ramp inside XWalk1? Road Slope (%) 0.5 Clear Space? N/A Road X Slope (%) N/A Clear Space to XWalk (in) N/A 1.0 N/A N/A N/A Any Obstructions? Storm Grate/Utility Hazard? N/A

Remove & Replace Curb Ramp With Two New Directional Ramps or Equivalent.
