## **Access Compliance Report Public Rights-of-Way** (Curb Ramps)

Intersection ID: 10035442 Main Street: RANDOLPH RD **Cross Street: N/A** Location: SW ADA ID: 2E140456F3BB Ramp Type: PerpDiag Initial Pass/Fail: Fail **Overall Compliance: No Severity Score:** 12.5

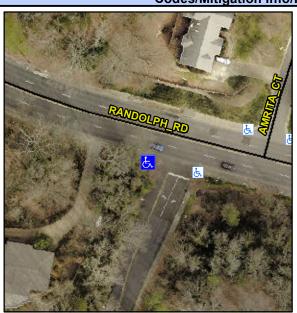
Field Measurements/Component Compliance						
	Compliance Description		Data	Com	oliance Description	Data
	N/A	Ramp Length (in)	71.0	Yes	Ramp Slope (%)	7.7
	Yes	Ramp Width (in)	101.0	No	Ramp XSlope (%)	6.2
	N/A	Flare Type LT	N/A	N/A	Flare Type RT	N/A
	N/A	Flare Slope LT (%)	N/A	N/A	Flare Slope RT (%)	N/A
	N/A	Flare Traversable LT?	N/A	N/A	Flare Traversable RT?	N/A
	N/A	Landing Length (in)	N/A	N/A	DWS Provided?	N/A
	N/A	Landing Width (in)	N/A	N/A	DWS Contrast?	N/A
	N/A	Landing Slope (%)	N/A	N/A	DWS Length (in)	N/A
	N/A	Landing X Slope (%)	N/A	N/A	DWS Full Width?	N/A
	N/A	Landing Curb? (Y/N)	N/A	N/A	DWS Offset (in)	N/A
	N/A	Shared Landing?	N/A			
	N/A	Gutter Ponding?	N/A	N/A	Gutter Slope (%)	N/A
	N/A	Gutter Lip Ht (in)	N/A	N/A	Gutter X Slope (%)	N/A
	N/A	Painted X Walk1?	No	N/A	Painted X Walk2?	No
		X Walk 1 Direction	To SE		X Walk 2 Direction	To NE
	N/A	X Walk 1 Width (in)	N/A	N/A	X Walk 2 Width (in)	N/A
		X Walk 1 Slope (%)	4.7		X Walk 2 Slope (%)	1.5

X Walk 1 X Slope (%)	0.5		X Walk 2 X Slope (%)	2.3
	N/A	Ramp inside XWalk1?	N/A	N/A	Ramp inside XWalk2?	N/A
		Road Slope (%)	2.0	N/A	Clear Space?	N/A
		Road X Slope (%)	2.7	N/A	Clear Space to XWalk (in)	N/A
	N/A	Any Obstructions?	N/A	N/A	Storm Grate/Utility Hazard?	N/A
		Obstruction Type			Storm Grate/Utility Type	
			N/A			N/A
				Yes	Surface Condition? (G/P)	Good

**ENTRANCE** Street 1 Name Stop Condition-Street 2 None Street 2 Name RANDOLPH RD Stop Condition-Street 1 None Possible Solutions: Remove & Replace Curb Ramp With Two New Directional Ramps or Equivalent. Surveyor Notes: N/A PROW/ADA: Not Found, R304.5.3

Total Cost: 3200.00
