# Access Compliance Report

## Public Rights-of-Way

| Intersection ID: 21863 | Main Street: BRYNHURST_DR | Cross Street: THORNCLIFF_DR | Location: SE |
| ADA ID: 2E3262F96EDE | Ramp Type: BlendTrans2 | Initial Pass/Fail: Pass | Overall Compliance: No |

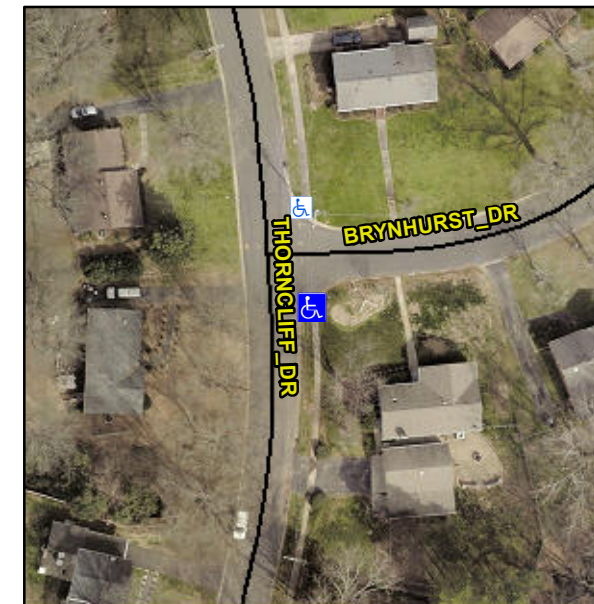
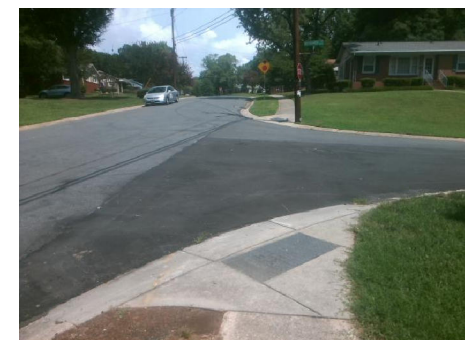
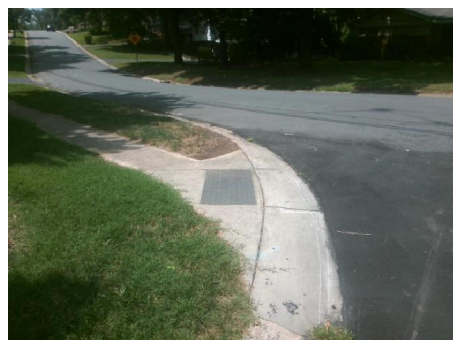
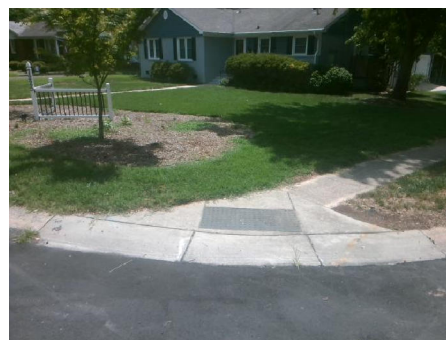
| | | Severity Score: 0.25 | |

**Not Found, R304.5.3, R305.2**

| Compliance | Description | Data | Compliance | Description | Data |
|---|---|---|---|---|---|
| Yes | Ramp Width (in) | 48.0 | No | BlendTrans XSlope (%) | 3.0 |
| N/A | Landing Curb? (Y/N) | No | No | DWS Offset (in) | 4.0 |
| Yes | Gutter Lip Ht (in) | 0.0 | No | Gutter X Slope (%) | 2.6 |
| | | | No | Curb Slope (%) | 7.3 |

**Remove & Replace Curb Ramp With Two New Directional Ramps or Equivalent. Remove & Replace Gutter.**

Total Cost: \$ 3950.00
