# Access Compliance Report

## Public Rights-of-Way

### (Curb Ramps)

Intersection ID: 17012	Main Street: MISSION_HILLS_RD	Cross Street: MORINGTON_LN	Location: NE
ADA ID: 2E3CEE46EB5A	Ramp Type: PerpDiag	Initial Pass/Fail: Fail	Overall Compliance: No
Severity Score: 13.75			
Codes/Mitigation Info/Possible Solution		Field Measurements/Component Compliance

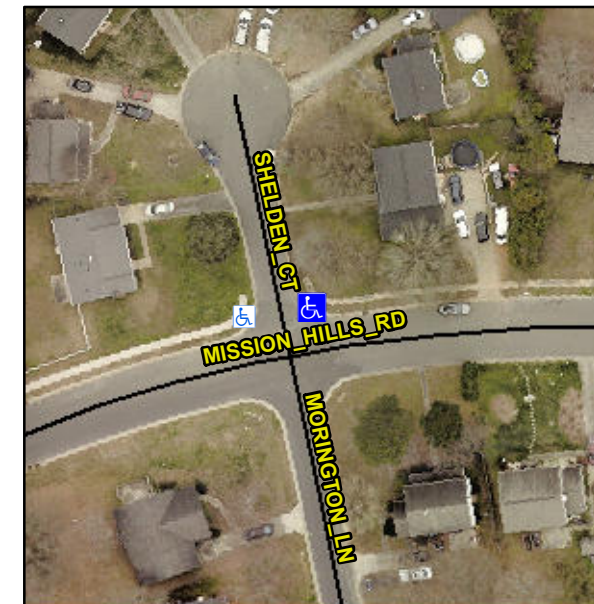
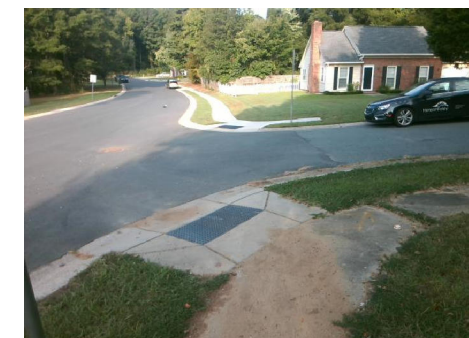
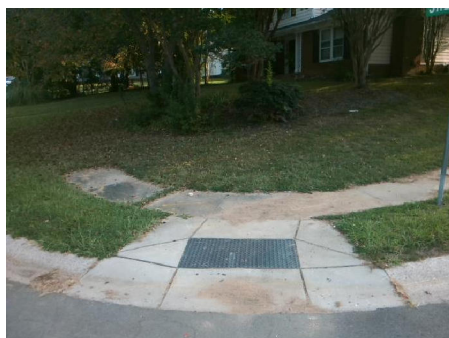
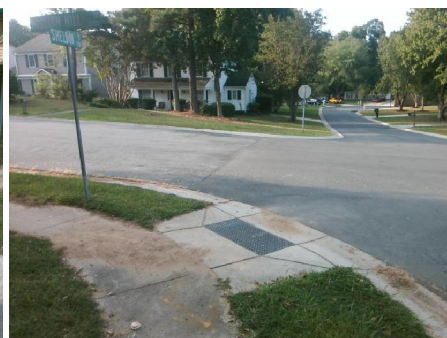
**Not Found, R304.2.2, R304.5.3**

Compliance	Description	Data	Compliance	Description	Data
N/A	Ramp Length (in)	48.0	No	Ramp Slope (%)	9.5
Yes	Ramp Width (in)	48.0	No	Ramp XSlope (%)	3.1
N/A	Flare Type LT	N/A	N/A	Flare Type RT	N/A
N/A	Flare Slope LT (%)	N/A	N/A	Flare Slope RT (%)	N/A
N/A	Flare Traversable LT?	N/A	N/A	Flare Traversable RT?	N/A
N/A	Landing Length (in)	N/A	N/A	DWS Provided?	N/A
N/A	Landing Width (in)	N/A	N/A	DWS Contrast?	N/A
N/A	Landing Slope (%)	N/A	N/A	DWS Length (in)	N/A
N/A	Landing X Slope (%)	N/A	N/A	DWS Full Width?	N/A
N/A	Landing Curb? (Y/N)	N/A	N/A	DWS Offset (in)	N/A
N/A	Shared Landing?	N/A			
N/A	Gutter Ponding?	N/A	N/A	Gutter Slope (%)	N/A
N/A	Gutter Lip Ht (in)	N/A	N/A	Gutter X Slope (%)	N/A
N/A	Painted X Walk1?	No	N/A	Painted X Walk2?	No
	X Walk 1 Direction	To W		X Walk 2 Direction	To S
N/A	X Walk 1 Width (in)	N/A	N/A	X Walk 2 Width (in)	N/A
	X Walk 1 Slope (%)	1.6		X Walk 2 Slope (%)	1.9
	X Walk 1 X Slope (%)	2.8		X Walk 2 X Slope (%)	1.9

N/A	Ramp inside XWalk1?	N/A	N/A	Ramp inside XWalk2?	N/A
	Road Slope (%)	0.2	N/A	Clear Space?	N/A
	Road X Slope (%)	1.4	N/A	Clear Space to XWalk (in)	N/A
N/A	Any Obstructions?	N/A	N/A	Storm Grate/Utility Hazard?	N/A
	Obstruction Type			Storm Grate/Utility Type	
		N/A			N/A
		Yes		Surface Condition? (G/P)	Good

**Remove & Replace Curb Ramp With Two New Directional Ramps or Equivalent.**
