# Access Compliance Report

## Public Rights-of-Way

### (Curb Ramps)

| Intersection ID: 53713 | Main Street: N_TRYON_ST | Cross Street: PERIWINKLE_HILL_AV | Location: S |

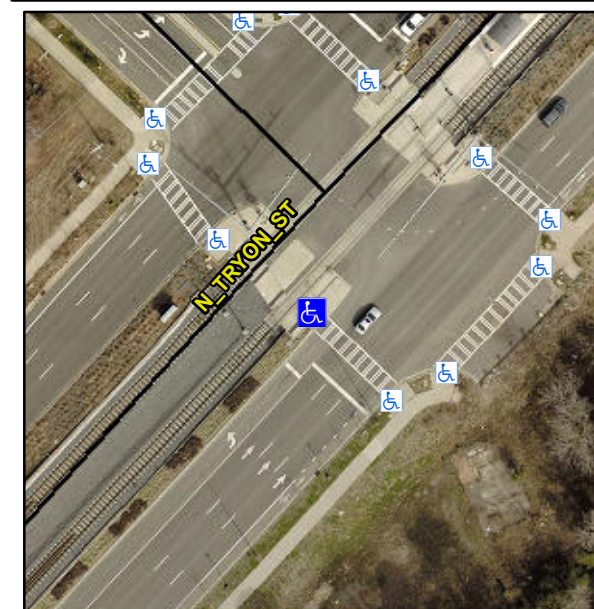
**R304.2.3**

| Compliance | Description | Data | Compliance | Description | Data |
|---|---|---|---|---|---|
| Yes | Flare Type | Curbed_NoWalkSurface | No | Flare Type | Curbed_WithWalkSurface |

**Remove & Replace Curbed Edge.**

\$ 300.00

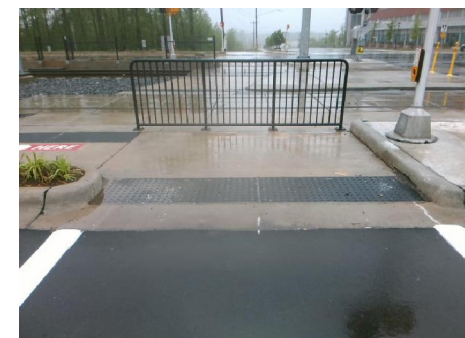
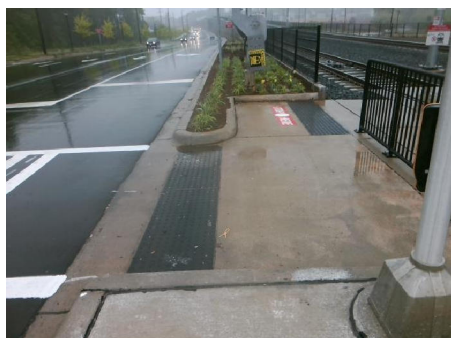
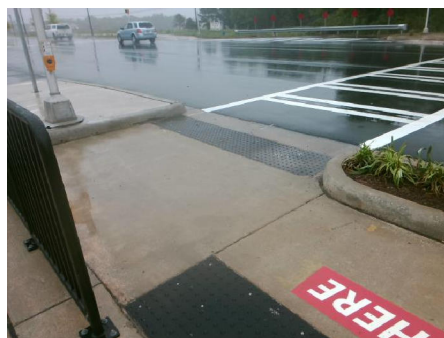
| ADA ID: 2E41FCB180DD | Ramp Type: BlendTrans2 | Initial Pass/Fail: Pass | Overall Compliance: No |
| Severity Score: 5 | | | |
