# Access Compliance Report

## Public Rights-of-Way

### (Curb Ramps)

| Intersection ID: 10039788 | Main Street: TOLLESON_AV | Cross Street: N/A | Location: NE |

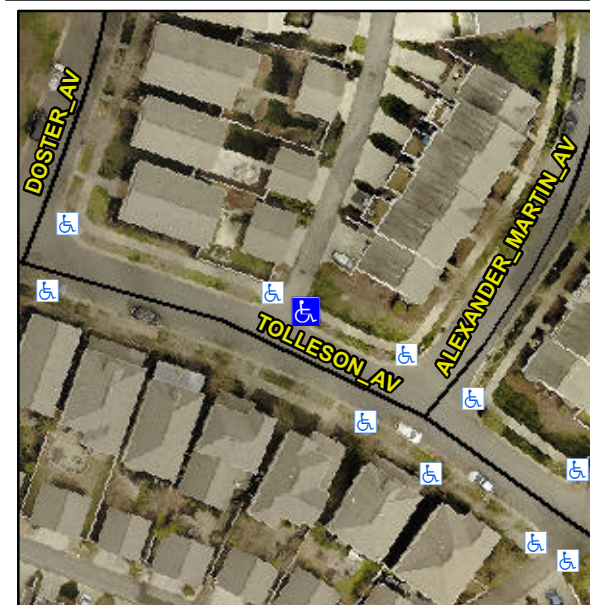
**Not Found, R304.5.1, R304.2.2, R304.5.3**

| Compliance | Description | Data | Compliance | Description | Data |
|---|---|---|---|---|---|
| N/A | Ramp Length (in) | 95.0 | No | Ramp Slope (%) | 8.5 |
| No | Ramp Width (in) | 33.0 | No | Ramp XSlope (%) | 2.5 |
| N/A | Gutter Ponding? | Yes | N/A | Gutter Slope (%) | N/A |

**Remove & Replace Curb Ramp With Two New Directional Ramps or Equivalent.**

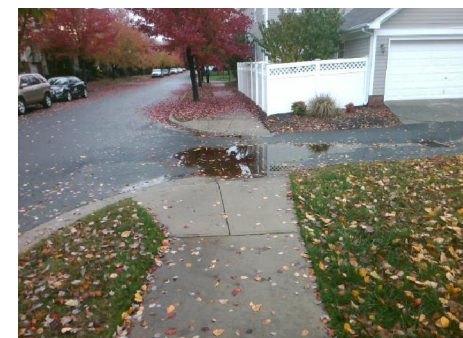
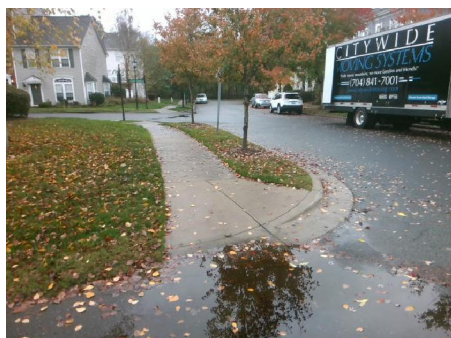
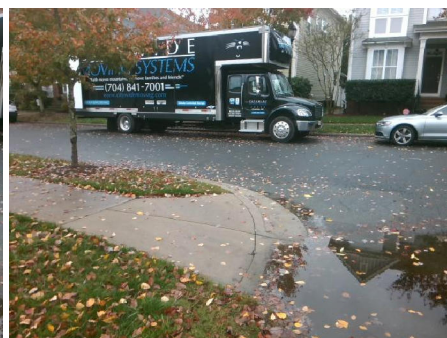
| Compliance | Description | Data | Compliance | Description | Data |
|---|---|---|---|---|---|
| | | | Yes | Surface Condition? (G/P) | Good |
