Access Compliance Report

Public Rights-of-Way

(Curb Ramps)

Intersection ID: 11650	Main Street: W_10TH_ST	Cross Street: N_CHURCH_ST	Location: S
ADA ID: 2E493BB48F1D	Ramp Type: PerpDiag	Initial Pass/Fail: Fail	Overall Compliance: No
		Severity Score: 12.5

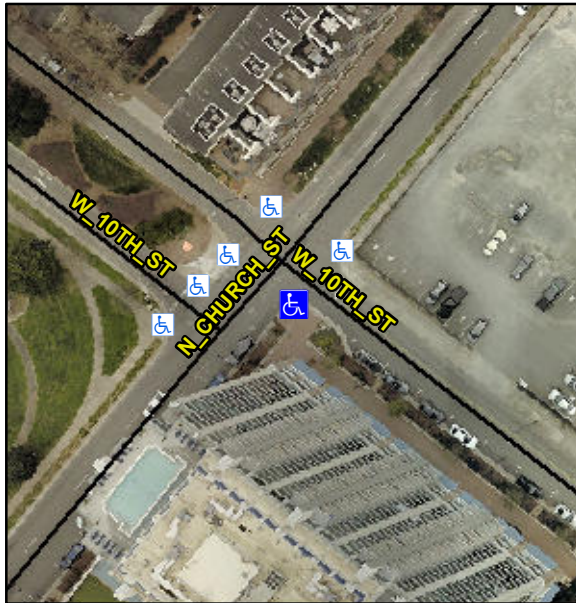
Compliance	Description	Data	Compliance	Description	Data
N/A	Ramp Length (in)	68.0	No	Ramp Slope (%)	9.2
Yes	Ramp Width (in)	48.0	Yes	Ramp XSlope (%)	1.3
N/A	Flare Type LT	N/A	N/A	Flare Type RT	N/A
N/A	Flare Slope LT (%)	N/A	N/A	Flare Slope RT (%)	N/A
N/A	Flare Traversable LT?	N/A	N/A	Flare Traversable RT?	N/A
N/A	Landing Length (in)	N/A	N/A	DWS Provided?	N/A
N/A	Landing Width (in)	N/A	N/A	DWS Contrast?	N/A
N/A	Landing Slope (%)	N/A	N/A	DWS Length (in)	N/A
N/A	Landing X Slope (%)	N/A	N/A	DWS Full Width?	N/A
N/A	Landing Curb? (Y/N)	N/A	N/A	DWS Offset (in)	N/A
N/A	Shared Landing?	N/A			
N/A	Gutter Ponding?	N/A	N/A	Gutter Slope (%)	N/A
N/A	Gutter Lip Ht (in)	N/A	N/A	Gutter X Slope (%)	N/A
N/A	Painted X Walk1?	No	N/A	Painted X Walk2?	No
	X Walk 1 Direction	To NE		X Walk 2 Direction	To NW
N/A	X Walk 1 Width (in)	N/A	N/A	X Walk 2 Width (in)	N/A
	X Walk 1 Slope (%)	1.6		X Walk 2 Slope (%)	0.9
	X Walk 1 X Slope (%)	2.0		X Walk 2 X Slope (%)	0.2

N/A	Ramp inside XWalk1?	N/A	N/A	Ramp inside XWalk2?	N/A
	Road Slope (%)	0.2	N/A	Clear Space?	N/A
	Road X Slope (%)	0.4	N/A	Clear Space to XWalk (in)	N/A
N/A	Any Obstructions?	N/A	N/A	Storm Grate/Utility Hazard?	N/A
	Obstruction Type			Storm Grate/Utility Type	
		N/A			N/A
			Yes	Surface Condition? (G/P)	Good

Remove & Replace Curb Ramp With Two New Directional Ramps or Equivalent.

R304.2.2

Total Cost: \$ 3200.00

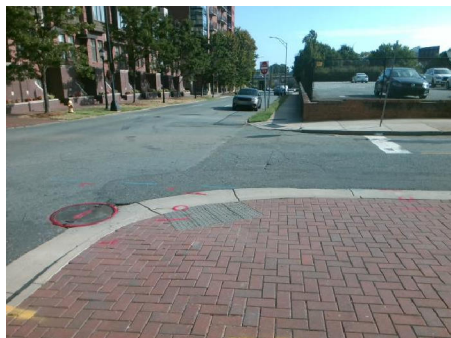
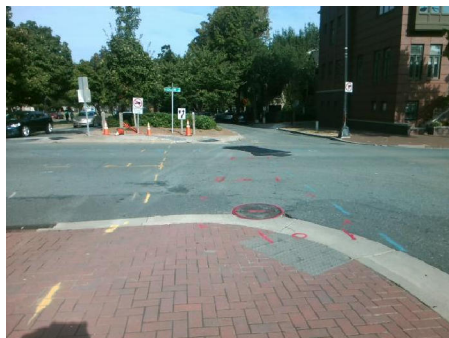
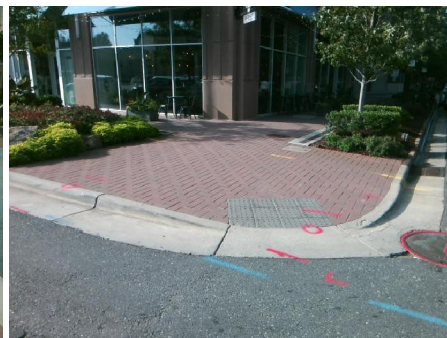
Street 1 Name **W 11TH ST**
 Stop Condition-Street 2 **StopSign**
 Street 2 Name **N CHURCH ST**
 Stop Condition-Street 1 **None**
