Access Compliance Report

Public Rights-of-Way

(Curb Ramps)

Intersection ID: 14518	Main Street: KENMORE_AV	Cross Street: RIDGEWAY_AV	Location: NE
ADA ID: 2E494C1D7D3B	Ramp Type: Directional1	Initial Pass/Fail: Fail	Overall Compliance: No
Severity Score: 1.25			
Codes/Mitigation Info/Possible Solution		Field Measurements/Component Compliance

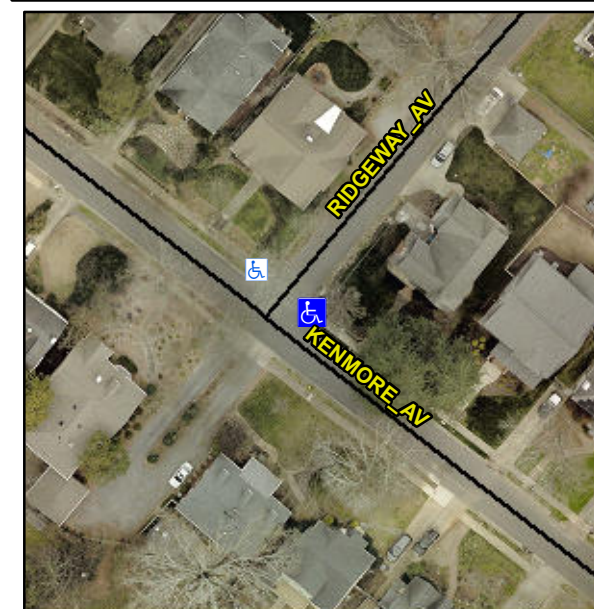
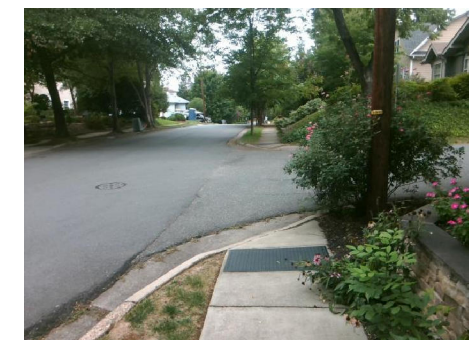
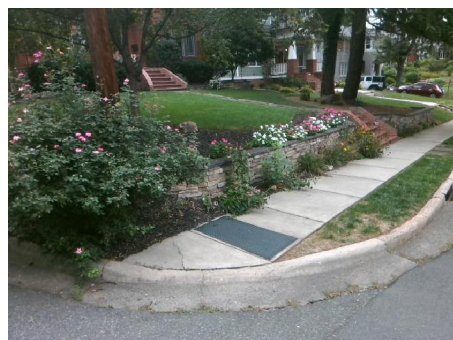
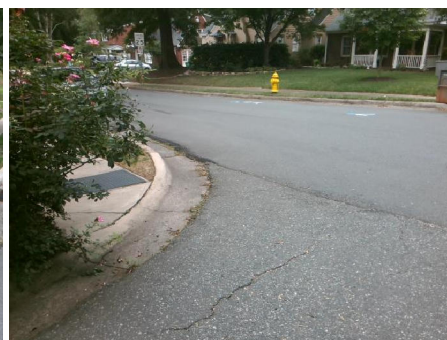
Compliance	Description	Data	Compliance	Description	Data
N/A	Ramp Length (in)	54.0	N/A	Grade Break?	N/A
Yes	Ramp Width (in)	52.0	N/A	Grade Break Slope (%)	0.0
Yes	Ramp Slope (%)	2.0	N/A	Grade Break XSlope (%)	0.0
No	Ramp XSlope (%)	4.4			
N/A	Flare Type LT	N/A	N/A	Flare Type RT	N/A
N/A	Flare Slope LT (%)	N/A	N/A	Flare Slope RT (%)	0.0
N/A	Flare Traversable LT?	N/A	N/A	Flare Traversable RT?	N/A
N/A	Landing Length (in)	0.0	N/A	DWS Provided?	N/A
N/A	Landing Width (in)	0.0	N/A	DWS Contrast?	N/A
N/A	Landing Slope (%)	0.0	N/A	DWS Length (in)	N/A
N/A	Landing X Slope (%)	0.0	N/A	DWS Full Width?	N/A
N/A	Landing Curb? (Y/N)	N/A	N/A	DWS Offset LT (in)	N/A
N/A	Shared Landing?	N/A	N/A	DWS Offset RT (in)	N/A
N/A	Gutter Ponding?	0.0	N/A	Gutter Slope (%)	N/A
N/A	Gutter Lip Ht (in)	0.0	N/A	Gutter X Slope (%)	N/A
N/A	Painted X Walk1?	No		Road Slope (%)	14.5
	X Walk 1 Direction	To NW		Road X Slope (%)	3.7
	X Walk 1 Width (in)	N/A		Clear Space?	N/A

X Walk 1 Slope (%)	14.5	N/A	Clear Space to XWalk (in)	N/A
	X Walk 1 X Slope (%)	3.7	N/A	Storm Grate/Utility Hazard?	N/A
N/A	Ramp inside XWalk1?	N/A		Storm Grate/Utility Type	
N/A	Any Obstructions?	N/A			N/A
	Obstruction Type		Yes	Surface Condition? (G/P)	Good
			N/A	Curb Slope (%)	23.9

Remove & Replace Entire Ramp.
