Access Compliance Report

Public Rights-of-Way

(Curb Ramps)

Intersection ID: 44831	Main Street: ST_JOHNS_CHURCH_RD	Cross Street: DECAPOLIS_DR	Location: NE
ADA ID: 2E4F026845E9	Ramp Type: Perp	Initial Pass/Fail: Fail	Overall Compliance: No
Codes/Mitigation Info/Possible Solution			Severity Score: 10
			Field Measurements/Component Compliance

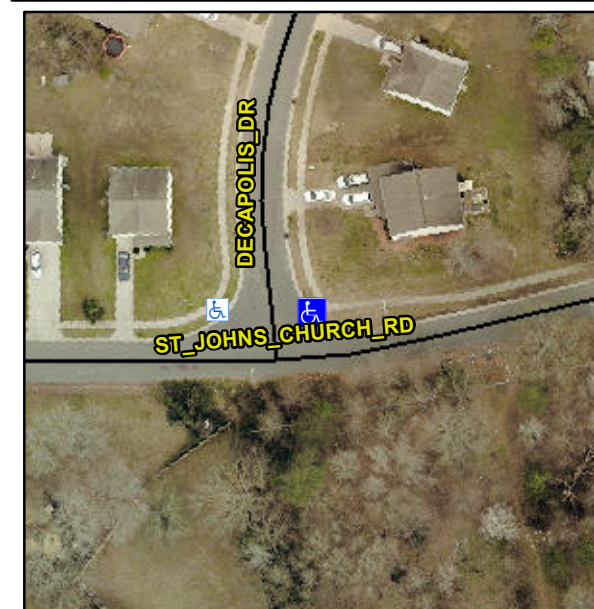
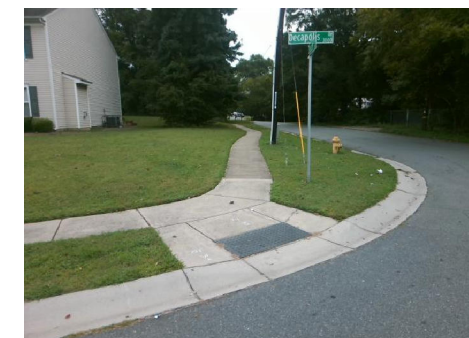
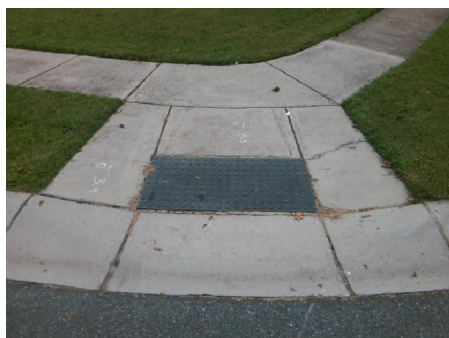
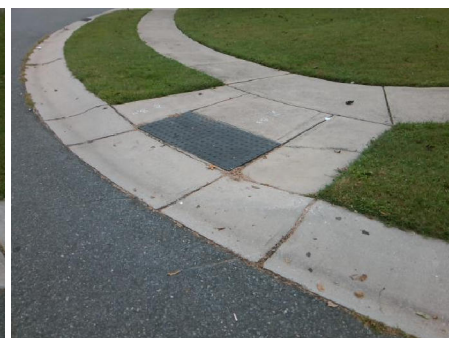
Not Found, R304.5.1, R304.5.3

Compliance	Description	Data	Compliance	Description	Data
N/A	Ramp Length (in)	59.0	Yes	Ramp Slope (%)	5.3
No	Ramp Width (in)	44.5	No	Ramp XSlope (%)	3.1
N/A	Flare Type LT	N/A	N/A	Flare Type RT	N/A
N/A	Flare Slope LT (%)	N/A	N/A	Flare Slope RT (%)	N/A
N/A	Flare Traversable LT?	N/A	N/A	Flare Traversable RT?	N/A
N/A	Landing Length (in)	N/A	N/A	DWS Provided?	N/A
N/A	Landing Width (in)	N/A	N/A	DWS Contrast?	N/A
N/A	Landing Slope (%)	N/A	N/A	DWS Length (in)	N/A
N/A	Landing X Slope (%)	N/A	N/A	DWS Full Width?	N/A
N/A	Landing Curb? (Y/N)	N/A	N/A	DWS Offset (in)	N/A
N/A	Shared Landing?	N/A			
N/A	Gutter Ponding?	N/A	N/A	Gutter Slope (%)	N/A
N/A	Gutter Lip Ht (in)	N/A	N/A	Gutter X Slope (%)	N/A
N/A	Painted X Walk1?	No	N/A	Painted X Walk2?	N/A
	X Walk 1 Direction	To W		X Walk 2 Direction	N/A
N/A	X Walk 1 Width (in)	N/A	N/A	X Walk 2 Width (in)	N/A
	X Walk 1 Slope (%)	3.4		X Walk 2 Slope (%)	N/A
	X Walk 1 X Slope (%)	1.0		X Walk 2 X Slope (%)	N/A

N/A	Ramp inside XWalk1?	N/A	N/A	Ramp inside XWalk2?	N/A
	Road Slope (%)	N/A	N/A	Clear Space?	N/A
	Road X Slope (%)	N/A	N/A	Clear Space to XWalk (in)	N/A
N/A	Any Obstructions?	N/A	N/A	Storm Grate/Utility Hazard?	N/A
	Obstruction Type			Storm Grate/Utility Type	
		N/A			N/A
			Yes	Surface Condition? (G/P)	Good

Possible Solutions:

Remove & Replace Entire Ramp.
