Intersection ID: 8483	Main Street: KENNESAW_DR	Cross Street: LASALLE_ST	Location:	SW
ADA ID: 2E544427841B	Ramp Type: PerpDiag	Initial Pass/Fail: Fail	Overall Compliance: No	Severity Score: 46.25

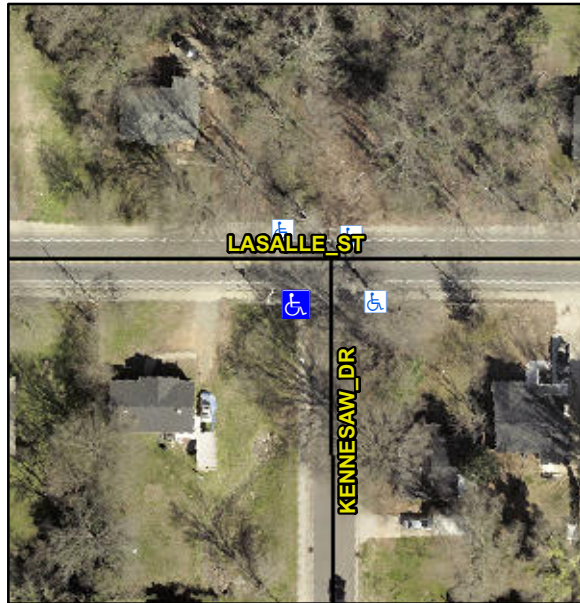
**Not Found, R304.5.1, R304.2.2,
R304.5.3**

Compliance	Description	Data	Compliance	Description	Data
N/A	Ramp Length (in)	59.5	No	Ramp Slope (%)	9.5
No	Ramp Width (in)	41.0	No	Ramp XSlope (%)	8.2
N/A	Flare Type LT	N/A	N/A	Flare Type RT	N/A
N/A	Flare Slope LT (%)	N/A	N/A	Flare Slope RT (%)	N/A
N/A	Flare Traversable LT?	N/A	N/A	Flare Traversable RT?	N/A
N/A	Landing Length (in)	N/A	N/A	DWS Provided?	N/A
N/A	Landing Width (in)	N/A	N/A	DWS Contrast?	N/A
N/A	Landing Slope (%)	N/A	N/A	DWS Length (in)	N/A
N/A	Landing X Slope (%)	N/A	N/A	DWS Full Width?	N/A
N/A	Landing Curb? (Y/N)	N/A	N/A	DWS Offset (in)	N/A
N/A	Shared Landing?	N/A			
N/A	Gutter Ponding?	N/A	N/A	Gutter Slope (%)	N/A
N/A	Gutter Lip Ht (in)	N/A	N/A	Gutter X Slope (%)	N/A
N/A	Painted X Walk1?	No	N/A	Painted X Walk2?	No
	X Walk 1 Direction	To E		X Walk 2 Direction	To N
N/A	X Walk 1 Width (in)	N/A	N/A	X Walk 2 Width (in)	N/A
	X Walk 1 Slope (%)	4.5		X Walk 2 Slope (%)	6.5
	X Walk 1 X Slope (%)	3.8		X Walk 2 X Slope (%)	7.6

N/A	Ramp inside XWalk1?	N/A	N/A	Ramp inside XWalk2?	N/A
	Road Slope (%)	7.2	N/A	Clear Space?	N/A
	Road X Slope (%)	0.2	N/A	Clear Space to XWalk (in)	N/A
N/A	Any Obstructions?	N/A	N/A	Storm Grate/Utility Hazard?	N/A
	Obstruction Type			Storm Grate/Utility Type	
		N/A			N/A
			Yes	Surface Condition? (G/P)	Good

Remove & Replace Curb Ramp With Two New Directional Ramps or Equivalent.

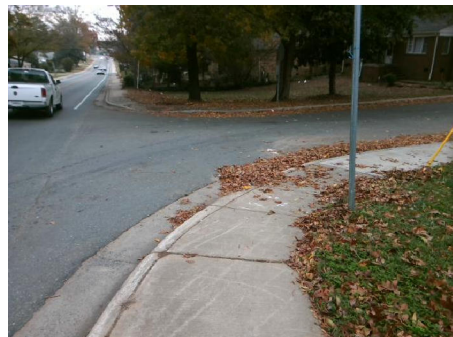
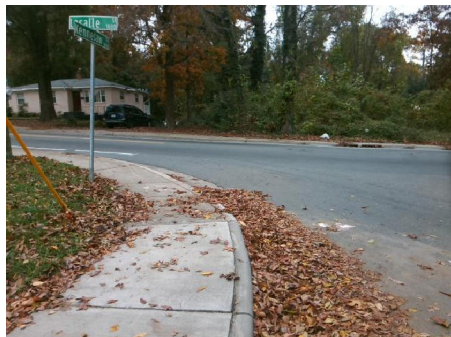
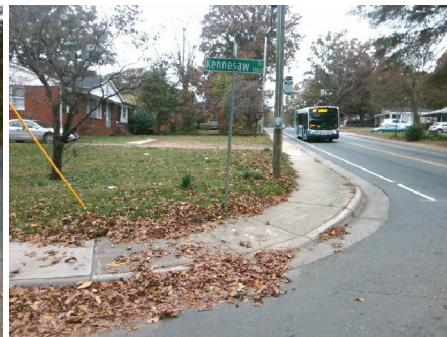
Street 1 Name	KENNESAW DR
Stop Condition-Street 2	StopSign
Street 2 Name	LASALLE ST
Stop Condition-Street 1	None
