# Access Compliance Report

## Public Rights-of-Way

### (Curb Ramps)

Intersection ID: 20622	Main Street: SANDY_PORTER_RD	Cross Street: TARAGATE_DR	Location: SW
ADA ID: 2E55EE847D53	Ramp Type: Directional1	Initial Pass/Fail: Fail	Overall Compliance: No
			Severity Score: 21.25

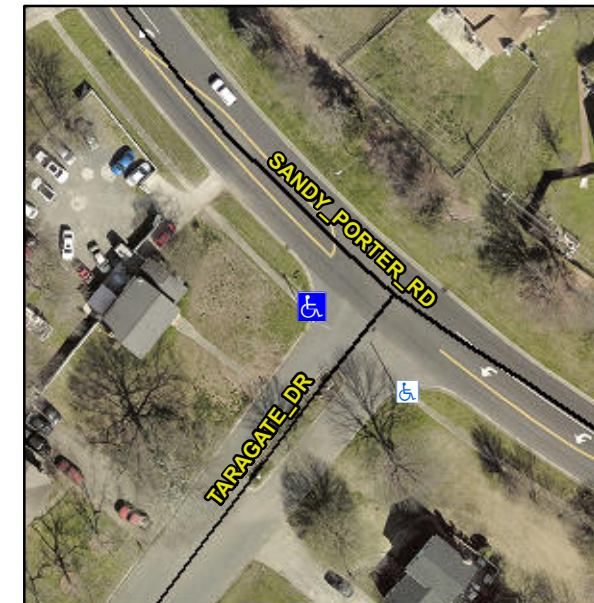
**R304.5.1, R304.2.2**

Compliance	Description	Data	Compliance	Description	Data
N/A	Ramp Length (in)	64.0	N/A	Grade Break?	N/A
No	Ramp Width (in)	42.0	N/A	Grade Break Slope (%)	0.0
No	Ramp Slope (%)	10.6	N/A	Grade Break XSlope (%)	0.0
Yes	Ramp XSlope (%)	1.6			
N/A	Flare Type LT	N/A	N/A	Flare Type RT	N/A
N/A	Flare Slope LT (%)	N/A	N/A	Flare Slope RT (%)	0.0
N/A	Flare Traversable LT?	N/A	N/A	Flare Traversable RT?	N/A
N/A	Landing Length (in)	0.0	N/A	DWS Provided?	N/A
N/A	Landing Width (in)	0.0	N/A	DWS Contrast?	N/A
N/A	Landing Slope (%)	0.0	N/A	DWS Length (in)	N/A
N/A	Landing X Slope (%)	0.0	N/A	DWS Full Width?	N/A
N/A	Landing Curb? (Y/N)	N/A	N/A	DWS Offset LT (in)	N/A
N/A	Shared Landing?	N/A	N/A	DWS Offset RT (in)	N/A
N/A	Gutter Ponding?	0.0	N/A	Gutter Slope (%)	N/A
N/A	Gutter Lip Ht (in)	0.0	N/A	Gutter X Slope (%)	N/A
N/A	Painted X Walk1?	No		Road Slope (%)	2.4
	X Walk 1 Direction	To SE		Road X Slope (%)	4.2
	X Walk 1 Width (in)	N/A		Clear Space?	N/A

X Walk 1 Slope (%)	2.4	N/A	Clear Space to XWalk (in)	N/A
	X Walk 1 X Slope (%)	4.2	N/A	Storm Grate/Utility Hazard?	N/A
N/A	Ramp inside XWalk1?	N/A		Storm Grate/Utility Type	
N/A	Any Obstructions?	N/A			N/A
	Obstruction Type		Yes	Surface Condition? (G/P)	Good
			N/A	Curb Slope (%)	15.6

**Remove & Replace Entire Ramp.**
