# Access Compliance Report

## Public Rights-of-Way

### (Curb Ramps)

Intersection ID: 16271	Main Street: ORMAND_CT	Cross Street: SLOAN_ST	Location:	N
ADA ID: 2E63EED8A430	Ramp Type: Directional1	Initial Pass/Fail: Fail	Overall Compliance: No	Severity Score: 1.25

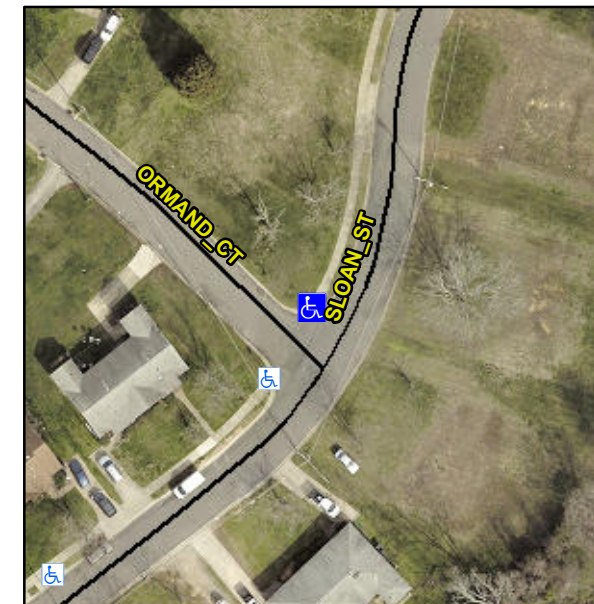
**R304.5.3**

Compliance	Description	Data	Compliance	Description	Data
N/A	Ramp Length (in)	55.0	N/A	Grade Break?	N/A
Yes	Ramp Width (in)	57.0	N/A	Grade Break Slope (%)	0.0
Yes	Ramp Slope (%)	5.9	N/A	Grade Break XSlope (%)	0.0
No	Ramp XSlope (%)	2.3			
N/A	Flare Type LT	N/A	N/A	Flare Type RT	N/A
N/A	Flare Slope LT (%)	N/A	N/A	Flare Slope RT (%)	0.0
N/A	Flare Traversable LT?	N/A	N/A	Flare Traversable RT?	N/A
N/A	Landing Length (in)	0.0	N/A	DWS Provided?	N/A
N/A	Landing Width (in)	0.0	N/A	DWS Contrast?	N/A
N/A	Landing Slope (%)	0.0	N/A	DWS Length (in)	N/A
N/A	Landing X Slope (%)	0.0	N/A	DWS Full Width?	N/A
N/A	Landing Curb? (Y/N)	N/A	N/A	DWS Offset LT (in)	N/A
N/A	Shared Landing?	N/A	N/A	DWS Offset RT (in)	N/A
N/A	Gutter Ponding?	0.0	N/A	Gutter Slope (%)	N/A
N/A	Gutter Lip Ht (in)	0.0	N/A	Gutter X Slope (%)	N/A
N/A	Painted X Walk1?	No		Road Slope (%)	8.8
	X Walk 1 Direction	To SW		Road X Slope (%)	2.2
	X Walk 1 Width (in)	N/A		Clear Space?	N/A

X Walk 1 Slope (%)	8.8	N/A	Clear Space to XWalk (in)	N/A
	X Walk 1 X Slope (%)	2.2	N/A	Storm Grate/Utility Hazard?	N/A
N/A	Ramp inside XWalk1?	N/A		Storm Grate/Utility Type	
N/A	Any Obstructions?	N/A			N/A
	Obstruction Type		Yes	Surface Condition? (G/P)	Good
			N/A	Curb Slope (%)	9.4

**Remove & Replace Entire Ramp.**
