# Access Compliance Report

## Public Rights-of-Way

### (Curb Ramps)

Intersection ID: 13752	Main Street: RENNELAER_AV	Cross Street: SOUTH_BV	Location:	N
ADA ID: 2E65F810F5B7	Ramp Type: Perp	Initial Pass/Fail: Pass	Overall Compliance: No	Severity Score: 0
Codes/Mitigation Info/Possible Solution		Field Measurements/Component Compliance

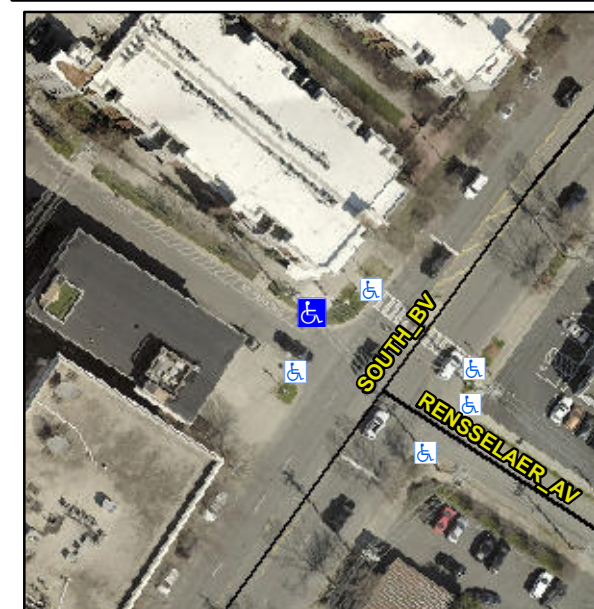
Compliance	Description	Data	Compliance	Description	Data
N/A	Ramp Length (in)	93.0	Yes	Ramp Slope (%)	7.9
Yes	Ramp Width (in)	48.0	Yes	Ramp XSlope (%)	0.1
N/A	Flare Type LT	Sloped	N/A	Flare Type RT	Sloped
N/A	Flare Slope LT (%)	34.2	N/A	Flare Slope RT (%)	29.8
N/A	Flare Traversable LT?	No	N/A	Flare Traversable RT?	No
Yes	Landing Length (in)	96.0	Yes	DWS Provided?	Yes
Yes	Landing Width (in)	96.0	Yes	DWS Contrast?	Yes
No	Landing Slope (%)	4.3	Yes	DWS Length (in)	24.0
Yes	Landing X Slope (%)	1.2	Yes	DWS Full Width?	Yes
N/A	Landing Curb? (Y/N)	No	No	DWS Offset (in)	6.0
N/A	Shared Landing?	No			
Yes	Gutter Ponding?	No	Yes	Gutter Slope (%)	0.5
Yes	Gutter Lip Ht (in)	0.0	No	Gutter X Slope (%)	3.2
N/A	Painted X Walk1?	No	N/A	Painted X Walk2?	N/A
	X Walk 1 Direction	To SW		X Walk 2 Direction	N/A
N/A	X Walk 1 Width (in)	N/A	N/A	X Walk 2 Width (in)	N/A
	X Walk 1 Slope (%)	5.9		X Walk 2 Slope (%)	N/A
	X Walk 1 X Slope (%)	1.6		X Walk 2 X Slope (%)	N/A

N/A	Ramp inside XWalk1?	N/A	N/A	Ramp inside XWalk2?	N/A
	Road Slope (%)	N/A	N/A	Clear Space?	Yes
	Road X Slope (%)	N/A	N/A	Clear Space to XWalk (in)	N/A
Yes	Any Obstructions?	No	Yes	Storm Grate/Utility Hazard?	No
	Obstruction Type			Storm Grate/Utility Type	
		N/A			N/A
			Yes	Surface Condition? (G/P)	Good

Possible Solutions:

**Remove & Replace Entire Ramp.  
Remove & Replace Gutter.**

**Not Found, R304.2.2-Perp, R304.3.2-  
Para, R305.2, R304.5.3**
