Intersection ID: 14901	Main Street: BALTIMORE_AV	Cross Street: FAIRWOOD_AV	Location:	NW
ADA ID: 2E6EAAF87434	Ramp Type: PerpDiag	Initial Pass/Fail: Fail	Overall Compliance: No	Severity Score: 37.5

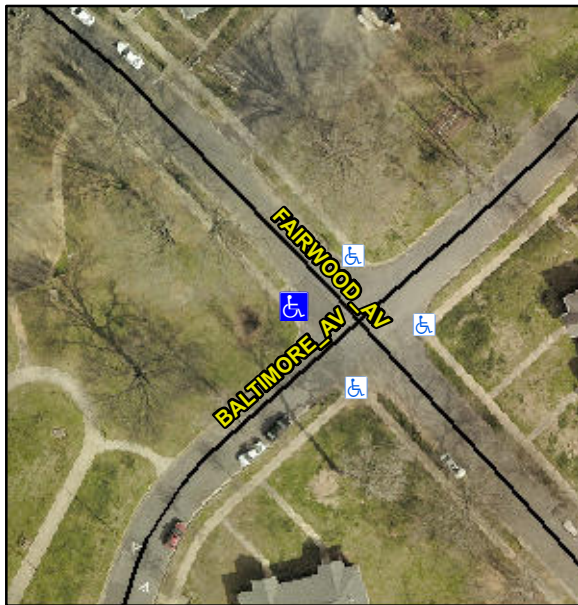
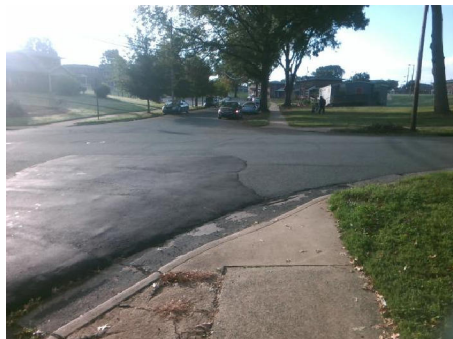
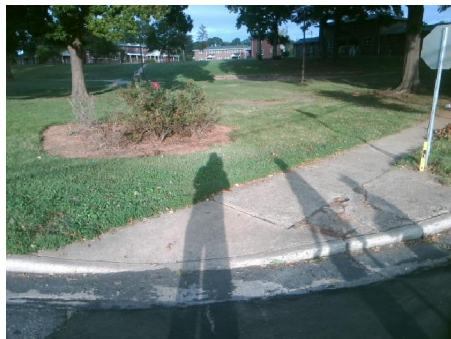
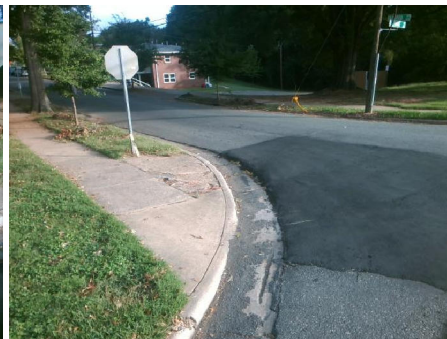
**Not Found, R304.2.2, R304.5.3**

Compliance	Description	Data	Compliance	Description	Data
N/A	Ramp Length (in)	48.0	No	Ramp Slope (%)	8.4
Yes	Ramp Width (in)	48.0	No	Ramp XSlope (%)	7.4
N/A	Flare Type LT	N/A	N/A	Flare Type RT	N/A
N/A	Flare Slope LT (%)	N/A	N/A	Flare Slope RT (%)	N/A
N/A	Flare Traversable LT?	N/A	N/A	Flare Traversable RT?	N/A
N/A	Landing Length (in)	N/A	N/A	DWS Provided?	N/A
N/A	Landing Width (in)	N/A	N/A	DWS Contrast?	N/A
N/A	Landing Slope (%)	N/A	N/A	DWS Length (in)	N/A
N/A	Landing X Slope (%)	N/A	N/A	DWS Full Width?	N/A
N/A	Landing Curb? (Y/N)	N/A	N/A	DWS Offset (in)	N/A
N/A	Shared Landing?	N/A			
N/A	Gutter Ponding?	N/A	N/A	Gutter Slope (%)	N/A
N/A	Gutter Lip Ht (in)	N/A	N/A	Gutter X Slope (%)	N/A
N/A	Painted X Walk1?	No	N/A	Painted X Walk2?	No
	X Walk 1 Direction	To NE		X Walk 2 Direction	To SE
N/A	X Walk 1 Width (in)	N/A	N/A	X Walk 2 Width (in)	N/A
	X Walk 1 Slope (%)	5.5		X Walk 2 Slope (%)	1.1
	X Walk 1 X Slope (%)	0.7		X Walk 2 X Slope (%)	3.4

N/A	Ramp inside XWalk1?	N/A	N/A	Ramp inside XWalk2?	N/A
	Road Slope (%)	6.9	N/A	Clear Space?	N/A
	Road X Slope (%)	7.8	N/A	Clear Space to XWalk (in)	N/A
N/A	Any Obstructions?	N/A	N/A	Storm Grate/Utility Hazard?	N/A
	Obstruction Type			Storm Grate/Utility Type	
		N/A			N/A
			Yes	Surface Condition? (G/P)	Good

**Remove & Replace Curb Ramp With Two New Directional Ramps or Equivalent.**
