Access Compliance Report

Public Rights-of-Way

(Curb Ramps)

Intersection ID: 43656	Main Street: HUNTINGTON_MEADOW_LN	Cross Street: CALLOW_FOREST_DR	Location: NE
ADA ID: 2E72D9EED145	Ramp Type: BlendTrans2	Initial Pass/Fail: Fail	Overall Compliance: No
Severity Score: 8.75			
Codes/Mitigation Info/Possible Solution		Field Measurements/Component Compliance

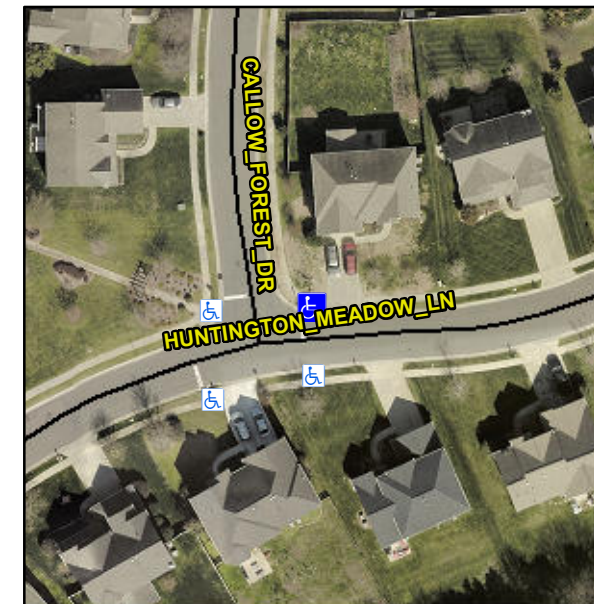
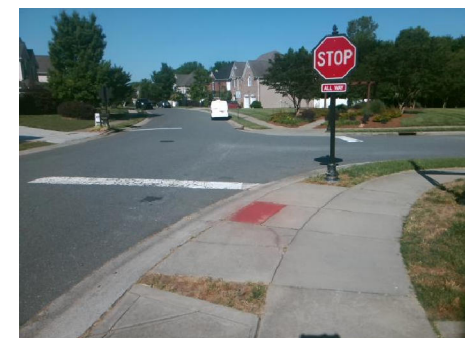
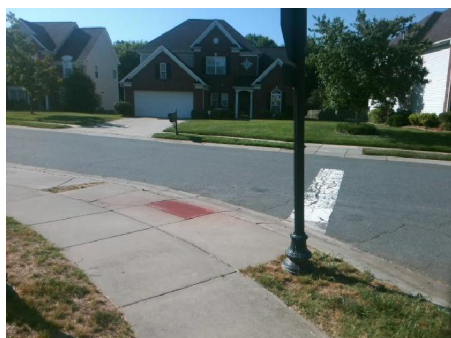
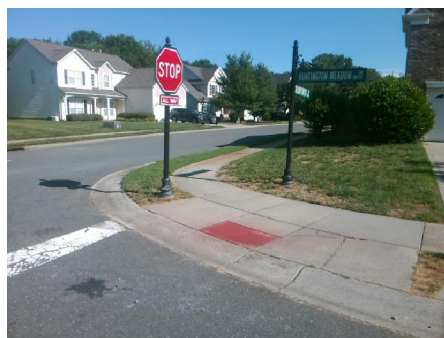
Not Found, R304.5.1

Compliance	Description	Data	Compliance	Description	Data
N/A	Ramp Length (in)	94.0	Yes	BlendTrans Slope (%)	4.4
No	Ramp Width (in)	39.5	Yes	BlendTrans XSlope (%)	2.0
N/A	Flare Type LT	N/A	N/A	Flare Type RT	N/A
N/A	Flare Slope LT (%)	N/A	N/A	Flare Slope RT (%)	N/A
N/A	Flare Traversable LT?	N/A	N/A	Flare Traversable RT?	N/A
N/A	Landing Length (in)	N/A	N/A	DWS Provided?	N/A
N/A	Landing Width (in)	N/A	N/A	DWS Contrast?	N/A
N/A	Landing Slope (%)	N/A	N/A	DWS Length (in)	N/A
N/A	Landing X Slope (%)	N/A	N/A	DWS Full Width?	N/A
N/A	Landing Curb? (Y/N)	N/A	N/A	DWS Offset (in)	N/A
N/A	Shared Landing?	N/A			
N/A	Gutter Ponding?	N/A	N/A	Gutter Slope (%)	N/A
N/A	Gutter Lip Ht (in)	N/A	N/A	Gutter X Slope (%)	N/A
N/A	Painted X Walk1?	No	N/A	Painted X Walk2?	No
	X Walk 1 Direction	To W		X Walk 2 Direction	To S
	X Walk 1 Width (in)	N/A		X Walk 2 Width (in)	N/A
	X Walk 1 Slope (%)	0.7		X Walk 2 Slope (%)	2.4
	X Walk 1 X Slope (%)	4.1		X Walk 2 X Slope (%)	2.1

N/A	Ramp inside XWalk1?	N/A	N/A	Ramp inside XWalk2?	N/A
	Road Slope (%)	0.8		Clear Space?	N/A
	Road X Slope (%)	1.1	N/A	Clear Space to XWalk (in)	N/A
N/A	Any Obstructions?	N/A	N/A	Storm Grate/Utility Hazard?	N/A
	Obstruction Type			Storm Grate/Utility Type	
		N/A			N/A
			Yes	Surface Condition? (G/P)	Good
			No	Curb Slope (%)	16.7

Remove & Replace Curb Ramp With Two New Directional Ramps or Equivalent.

Total Cost: \$ 3200.00
