Access Compliance Report

Public Rights-of-Way

(Curb Ramps)

Intersection ID: 18365	Main Street: S_TRYON_ST	Cross Street: W_TYVOLA_RD	Location: SE
ADA ID: 2E7D1972F6A0	Ramp Type: PerpDiag	Initial Pass/Fail: Fail	Overall Compliance: No
Severity Score: 12.5			
Codes/Mitigation Info/Possible Solution		Field Measurements/Component Compliance

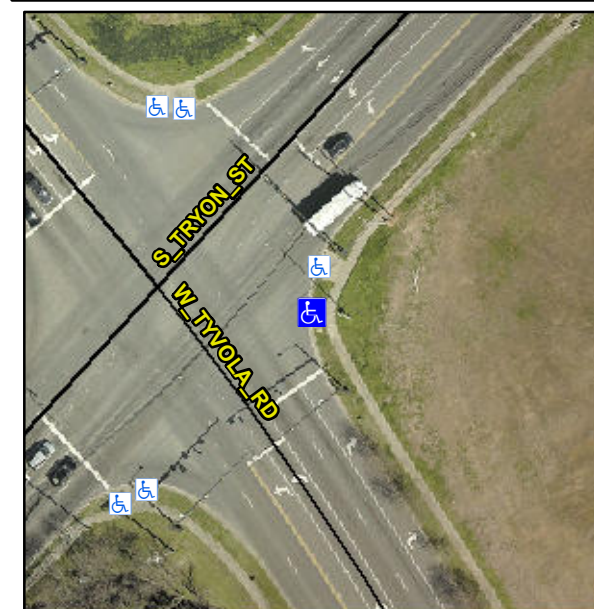
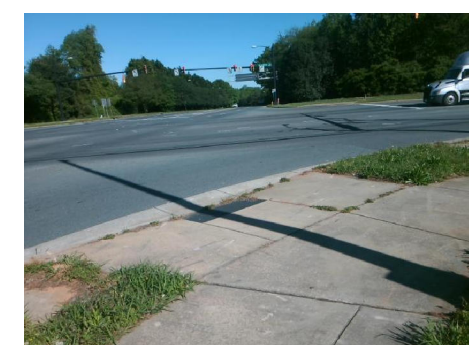
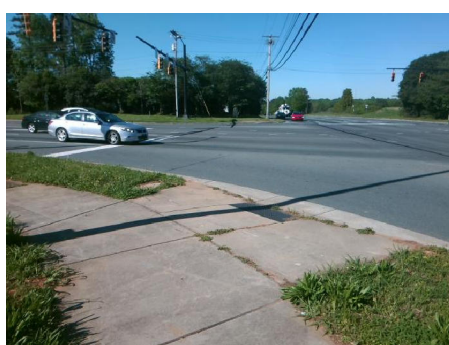
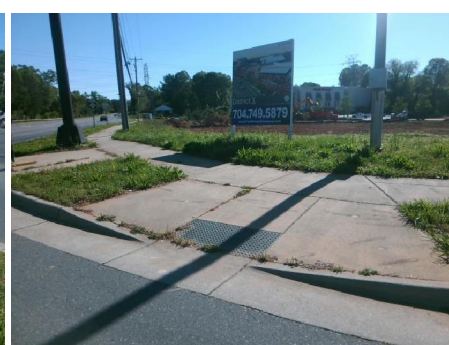
Compliance	Description	Data	Compliance	Description	Data
N/A	Ramp Length (in)	78.0	No	Ramp Slope (%)	9.1
Yes	Ramp Width (in)	48.0	Yes	Ramp XSlope (%)	0.9
N/A	Flare Type LT	N/A	N/A	Flare Type RT	N/A
N/A	Flare Slope LT (%)	N/A	N/A	Flare Slope RT (%)	N/A
N/A	Flare Traversable LT?	N/A	N/A	Flare Traversable RT?	N/A
N/A	Landing Length (in)	N/A	N/A	DWS Provided?	N/A
N/A	Landing Width (in)	N/A	N/A	DWS Contrast?	N/A
N/A	Landing Slope (%)	N/A	N/A	DWS Length (in)	N/A
N/A	Landing X Slope (%)	N/A	N/A	DWS Full Width?	N/A
N/A	Landing Curb? (Y/N)	N/A	N/A	DWS Offset (in)	N/A
N/A	Shared Landing?	N/A			
N/A	Gutter Ponding?	N/A	N/A	Gutter Slope (%)	N/A
N/A	Gutter Lip Ht (in)	N/A	N/A	Gutter X Slope (%)	N/A
N/A	Painted X Walk1?	No	N/A	Painted X Walk2?	No
	X Walk 1 Direction	To NW		X Walk 2 Direction	To SW
N/A	X Walk 1 Width (in)	N/A	N/A	X Walk 2 Width (in)	N/A
	X Walk 1 Slope (%)	2.0		X Walk 2 Slope (%)	3.1
	X Walk 1 X Slope (%)	1.4		X Walk 2 X Slope (%)	2.0

N/A	Ramp inside XWalk1?	N/A	N/A	Ramp inside XWalk2?	N/A
	Road Slope (%)	1.0	N/A	Clear Space?	N/A
	Road X Slope (%)	3.0	N/A	Clear Space to XWalk (in)	N/A
N/A	Any Obstructions?	N/A	N/A	Storm Grate/Utility Hazard?	N/A
	Obstruction Type			Storm Grate/Utility Type	
		N/A			N/A
		Yes		Surface Condition? (G/P)	Good

Possible Solutions:

Remove & Replace Curb Ramp With Two New Directional Ramps or Equivalent.
