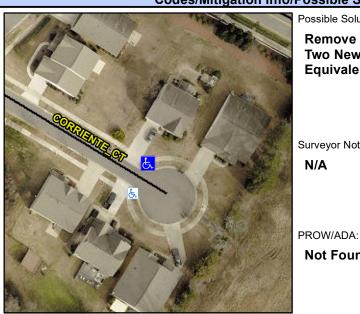
Intersection ID: 10018079Main Street: CORRIENTE_CTCross Street: N/ALocation: NWADA ID: 2E884DD8131DRamp Type: BlendTrans1Initial Pass/Fail: FailOverall Compliance: NoSeverity Score: 8.75

Compliance Description Data Compliance Description	
	Data
N/A Ramp Length (in) 72.0 Yes BlendTrans Slope (%)	4.9
No Ramp Width (in) 47.0 Yes BlendTrans XSlope (%)	1.8
N/A Flare Type LT N/A N/A Flare Type RT	N/A
N/A Flare Slope LT (%) N/A N/A Flare Slope RT (%)	N/A
N/A Flare Traversable LT? N/A N/A Flare Traversable RT?	N/A
N/A Landing Length (in) N/A N/A DWS Provided?	N/A
N/A Landing Width (in) N/A N/A DWS Contrast?	N/A
N/A Landing Slope (%) N/A N/A DWS Length (in)	N/A
N/A Landing X Slope (%) N/A N/A DWS Full Width?	N/A
N/A Landing Curb? (Y/N) N/A N/A DWS Offset (in)	N/A
N/A Shared Landing? N/A	
N/A Gutter Ponding? N/A N/A Gutter Slope (%)	N/A
N/A Gutter Lip Ht (in) 0.5 N/A Gutter X Slope (%)	N/A
N/A Painted X Walk1? No N/A Painted X Walk2?	N/A
X Walk 1 Direction To SW X Walk 2 Direction	N/A
X Walk 1 Width (in) N/A X Walk 2 Width (in)	N/A
X Walk 1 Slope (%) 3.0 X Walk 2 Slope (%)	N/A
X Walk 1 X Slope (%) 3.0 X Walk 2 X Slope (%)	N/A

N/A Ramp inside XWalk1? N/A N/A Ramp inside XWalk2?	N/A
Road Slope (%) 3.0 Clear Space?	N/A
Road X Slope (%) 3.0 N/A Clear Space to XWalk (in)) N/A
N/A Any Obstructions? N/A N/A Storm Grate/Utility Hazard	d? N/A
Obstruction Type Storm Grate/Utility Type	
N/A	N/A
Yes Surface Condition? (G/P)	Good
No Curb Slope (%)	11.9

Remove & Replace Curb Ramp With
Two New Directional Ramps or
Equivalent.
