# Access Compliance Report

## Public Rights-of-Way

### (Curb Ramps)

Intersection ID: 21358	Main Street: SARDIS_RD	Cross Street: SUMMERMORE_DR	Location: W
ADA ID: 2E9EEED33EAF	Ramp Type: PerpDiag	Initial Pass/Fail: Fail	Overall Compliance: No
Severity Score: 58.75			
Codes/Mitigation Info/Possible Solution		Field Measurements/Component Compliance

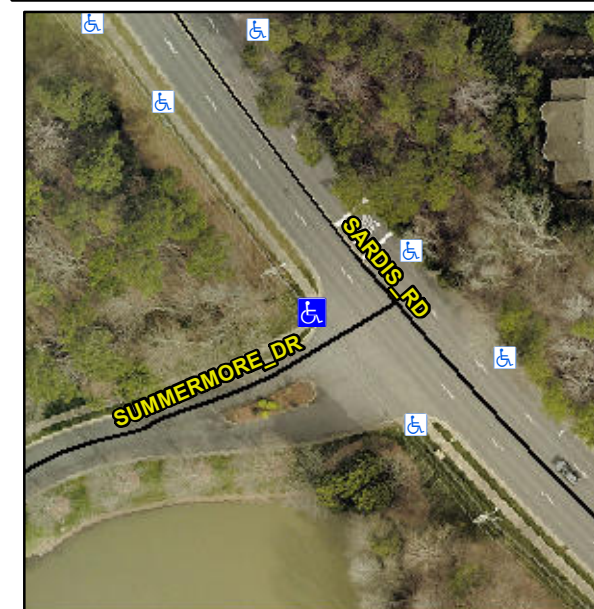
**N/A**

**R304.5.1, R304.2.2, R304.5.3**

Compliance	Description	Data	Compliance	Description	Data
N/A	Ramp Length (in)	58.5	No	Ramp Slope (%)	13.0
No	Ramp Width (in)	39.0	No	Ramp XSlope (%)	10.2
N/A	Flare Type LT	N/A	N/A	Flare Type RT	N/A
N/A	Flare Slope LT (%)	N/A	N/A	Flare Slope RT (%)	N/A
N/A	Flare Traversable LT?	N/A	N/A	Flare Traversable RT?	N/A
N/A	Landing Length (in)	N/A	N/A	DWS Provided?	N/A
N/A	Landing Width (in)	N/A	N/A	DWS Contrast?	N/A
N/A	Landing Slope (%)	N/A	N/A	DWS Length (in)	N/A
N/A	Landing X Slope (%)	N/A	N/A	DWS Full Width?	N/A
N/A	Landing Curb? (Y/N)	N/A	N/A	DWS Offset (in)	N/A
N/A	Shared Landing?	N/A			
N/A	Gutter Ponding?	N/A	N/A	Gutter Slope (%)	N/A
N/A	Gutter Lip Ht (in)	0.5	N/A	Gutter X Slope (%)	N/A
N/A	Painted X Walk1?	No	N/A	Painted X Walk2?	No
	X Walk 1 Direction	To SE		X Walk 2 Direction	To NE
N/A	X Walk 1 Width (in)	N/A	N/A	X Walk 2 Width (in)	N/A
	X Walk 1 Slope (%)	1.0		X Walk 2 Slope (%)	9.4
	X Walk 1 X Slope (%)	6.3		X Walk 2 X Slope (%)	2.6

N/A	Ramp inside XWalk1?	N/A	N/A	Ramp inside XWalk2?	N/A
	Road Slope (%)	5.6	N/A	Clear Space?	N/A
	Road X Slope (%)	6.8	N/A	Clear Space to XWalk (in)	N/A
N/A	Any Obstructions?	N/A	N/A	Storm Grate/Utility Hazard?	N/A
	Obstruction Type			Storm Grate/Utility Type	
		N/A			N/A
			Yes	Surface Condition? (G/P)	Good

**Remove & Replace Curb Ramp With Two New Directional Ramps or Equivalent.**

Total Cost: \$ 3200.00
