Access Compliance Report

Public Rights-of-Way

(Curb Ramps)

Intersection ID: 44482	Main Street: AINSWORTH_ST	Cross Street: REDDING_GLEN_AV	Location: NE
ADA ID: 2EAE9556C872	Ramp Type: PerpDiag	Initial Pass/Fail: Fail	Overall Compliance: No
		Severity Score: 10

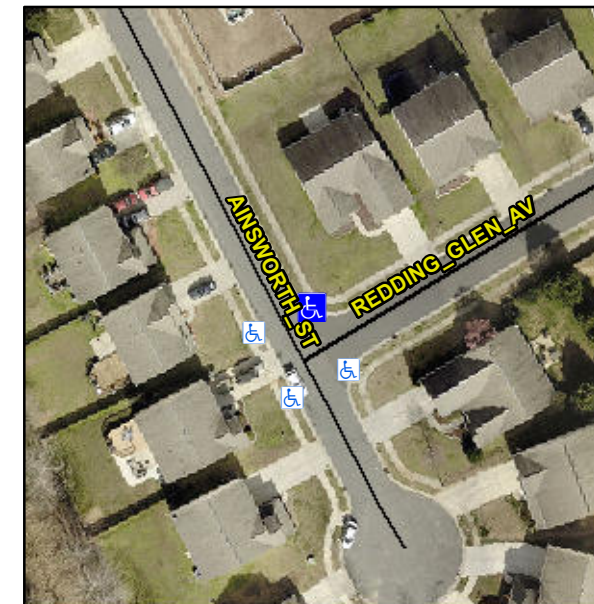
Not Found, R304.5.1, R304.5.3

Compliance	Description	Data	Compliance	Description	Data
N/A	Ramp Length (in)	48.0	Yes	Ramp Slope (%)	7.3
No	Ramp Width (in)	46.5	No	Ramp XSlope (%)	3.3
N/A	Flare Type LT	N/A	N/A	Flare Type RT	N/A
N/A	Flare Slope LT (%)	N/A	N/A	Flare Slope RT (%)	N/A
N/A	Flare Traversable LT?	N/A	N/A	Flare Traversable RT?	N/A
N/A	Landing Length (in)	N/A	N/A	DWS Provided?	N/A
N/A	Landing Width (in)	N/A	N/A	DWS Contrast?	N/A
N/A	Landing Slope (%)	N/A	N/A	DWS Length (in)	N/A
N/A	Landing X Slope (%)	N/A	N/A	DWS Full Width?	N/A
N/A	Landing Curb? (Y/N)	N/A	N/A	DWS Offset (in)	N/A
N/A	Shared Landing?	N/A			
N/A	Gutter Ponding?	N/A	N/A	Gutter Slope (%)	N/A
N/A	Gutter Lip Ht (in)	N/A	N/A	Gutter X Slope (%)	N/A
N/A	Painted X Walk1?	No	N/A	Painted X Walk2?	No
	X Walk 1 Direction	To W		X Walk 2 Direction	To S
N/A	X Walk 1 Width (in)	N/A	N/A	X Walk 2 Width (in)	N/A
	X Walk 1 Slope (%)	2.3		X Walk 2 Slope (%)	4.0
	X Walk 1 X Slope (%)	4.5		X Walk 2 X Slope (%)	0.8

N/A	Ramp inside XWalk1?	N/A	N/A	Ramp inside XWalk2?	N/A
	Road Slope (%)	3.7	N/A	Clear Space?	N/A
	Road X Slope (%)	1.5	N/A	Clear Space to XWalk (in)	N/A
N/A	Any Obstructions?	N/A	N/A	Storm Grate/Utility Hazard?	N/A
	Obstruction Type			Storm Grate/Utility Type	
		N/A			N/A
			Yes	Surface Condition? (G/P)	Good

Remove & Replace Curb Ramp With Two New Directional Ramps or Equivalent.
