Access Compliance Report

Public Rights-of-Way

(Curb Ramps)

Intersection ID: 47231	Main Street: ROMANY_RD	Cross Street: MOREHEAD_MEDICAL_DR	Location: SE
ADA ID: 2EAF1216E1D8	Ramp Type: PerpDiag	Initial Pass/Fail: Fail	Overall Compliance: No
Codes/Mitigation Info/Possible Solution		Field Measurements/Component Compliance	
		Severity Score: 50

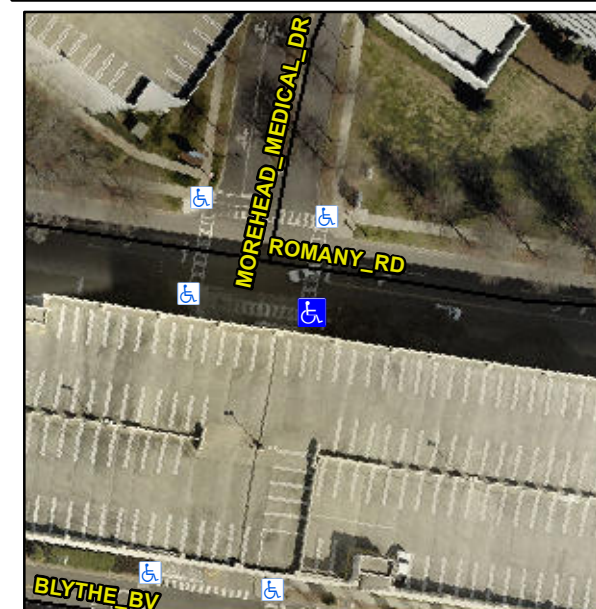
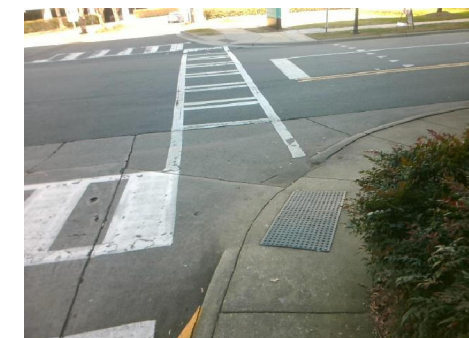
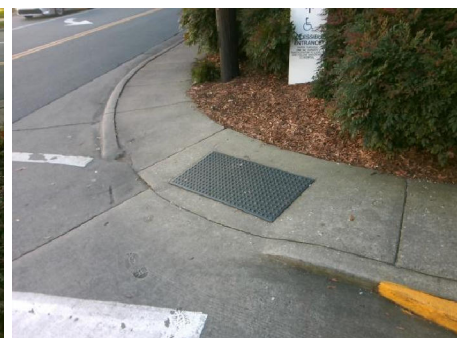
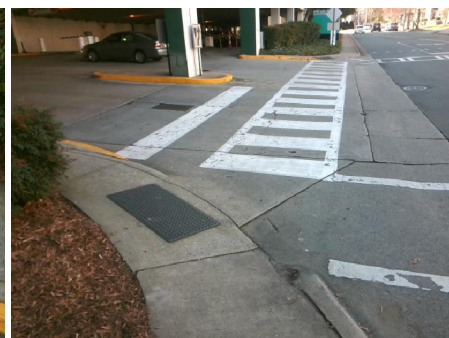
R304.2.2, R304.5.3

Compliance	Description	Data	Compliance	Description	Data
N/A	Ramp Length (in)	47.0	No	Ramp Slope (%)	17.5
Yes	Ramp Width (in)	93.0	No	Ramp XSlope (%)	8.9
N/A	Flare Type LT	N/A	N/A	Flare Type RT	N/A
N/A	Flare Slope LT (%)	N/A	N/A	Flare Slope RT (%)	N/A
N/A	Flare Traversable LT?	N/A	N/A	Flare Traversable RT?	N/A
N/A	Landing Length (in)	N/A	N/A	DWS Provided?	N/A
N/A	Landing Width (in)	N/A	N/A	DWS Contrast?	N/A
N/A	Landing Slope (%)	N/A	N/A	DWS Length (in)	N/A
N/A	Landing X Slope (%)	N/A	N/A	DWS Full Width?	N/A
N/A	Landing Curb? (Y/N)	N/A	N/A	DWS Offset (in)	N/A
N/A	Shared Landing?	N/A			
N/A	Gutter Ponding?	N/A	N/A	Gutter Slope (%)	N/A
N/A	Gutter Lip Ht (in)	N/A	N/A	Gutter X Slope (%)	N/A
N/A	Painted X Walk1?	Yes	N/A	Painted X Walk2?	Yes
	X Walk 1 Direction	To N		X Walk 2 Direction	To W
N/A	X Walk 1 Width (in)	57.0	N/A	X Walk 2 Width (in)	60.0
	X Walk 1 Slope (%)	0.6		X Walk 2 Slope (%)	1.8
	X Walk 1 X Slope (%)	2.0		X Walk 2 X Slope (%)	3.8

N/A	Ramp inside XWalk1?	Yes	N/A	Ramp inside XWalk2?	Yes
	Road Slope (%)	9.0	N/A	Clear Space?	N/A
	Road X Slope (%)	0.5	N/A	Clear Space to XWalk (in)	N/A
N/A	Any Obstructions?	N/A	N/A	Storm Grate/Utility Hazard?	N/A
	Obstruction Type			Storm Grate/Utility Type	
		N/A			N/A
		Yes		Surface Condition? (G/P)	Good

Remove & Replace Curb Ramp With Two New Directional Ramps or Equivalent.
