Access Compliance Report

Public Rights-of-Way

(Curb Ramps)

Intersection ID: 14620	Main Street: EUCLID_AV	Cross Street: MCDONALD_AV	Location:	N
ADA ID: 2EAF4D6FE763	Ramp Type: Directional1	Initial Pass/Fail: Fail	Overall Compliance: No	Severity Score: 1.25
Codes/Mitigation Info/Possible Solution		Field Measurements/Component Compliance

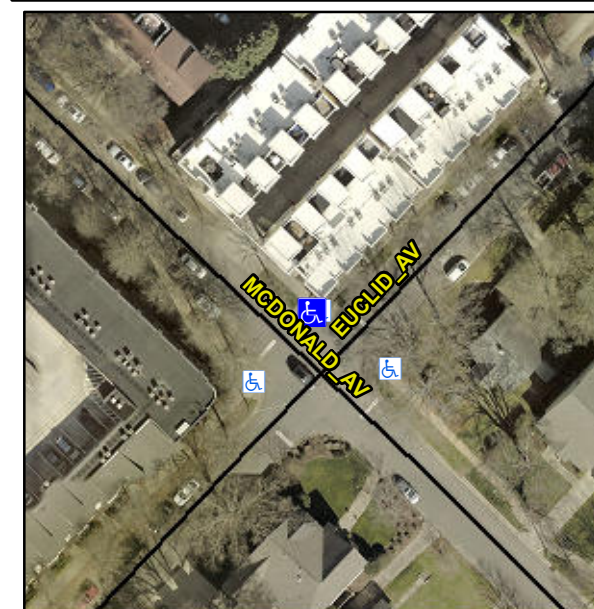
DWS LIP 1.0"

PROW/ADA:

R304.5.3

Compliance	Description	Data	Compliance	Description	Data
N/A	Ramp Length (in)	32.0	N/A	Grade Break?	N/A
Yes	Ramp Width (in)	73.0	N/A	Grade Break Slope (%)	0.0
Yes	Ramp Slope (%)	7.3	N/A	Grade Break XSlope (%)	0.0
No	Ramp XSlope (%)	3.7			
N/A	Flare Type LT	N/A	N/A	Flare Type RT	N/A
N/A	Flare Slope LT (%)	N/A	N/A	Flare Slope RT (%)	0.0
N/A	Flare Traversable LT?	N/A	N/A	Flare Traversable RT?	N/A
N/A	Landing Length (in)	0.0	N/A	DWS Provided?	N/A
N/A	Landing Width (in)	0.0	N/A	DWS Contrast?	N/A
N/A	Landing Slope (%)	0.0	N/A	DWS Length (in)	N/A
N/A	Landing X Slope (%)	0.0	N/A	DWS Full Width?	N/A
N/A	Landing Curb? (Y/N)	N/A	N/A	DWS Offset LT (in)	N/A
N/A	Shared Landing?	N/A	N/A	DWS Offset RT (in)	N/A
N/A	Gutter Ponding?	0.0	N/A	Gutter Slope (%)	N/A
N/A	Gutter Lip Ht (in)	0.0	N/A	Gutter X Slope (%)	N/A
N/A	Painted X Walk1?	No		Road Slope (%)	4.8
	X Walk 1 Direction	To SW		Road X Slope (%)	0.8
	X Walk 1 Width (in)	N/A		Clear Space?	N/A

X Walk 1 Slope (%)	4.8	N/A	Clear Space to XWalk (in)	N/A
	X Walk 1 X Slope (%)	0.8	N/A	Storm Grate/Utility Hazard?	N/A
N/A	Ramp inside XWalk1?	N/A		Storm Grate/Utility Type	
N/A	Any Obstructions?	N/A			N/A
	Obstruction Type		Yes	Surface Condition? (G/P)	Good
			N/A	Curb Slope (%)	12.1

Possible Solutions:

Remove & Replace Entire Ramp.

Total Cost: \$ 1600.00
