Access Compliance Report

Public Rights-of-Way

(Curb Ramps)

Intersection ID: 29749	Main Street: ARMORCREST_LN	Cross Street: JORDANUS_CT	Location: NW
ADA ID: 2EB3F6A0FEC5	Ramp Type: BlendTrans1	Initial Pass/Fail: Fail	Overall Compliance: No
Severity Score: 8.75			
Codes/Mitigation Info/Possible Solution		Field Measurements/Component Compliance

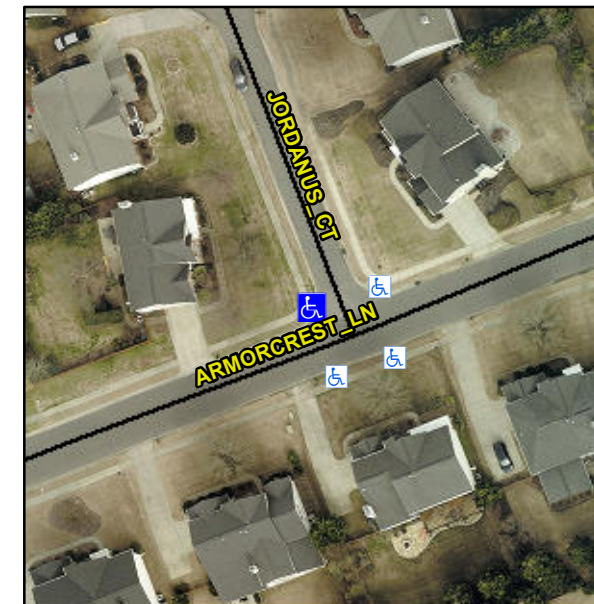
Not Found, R304.5.1

Compliance	Description	Data	Compliance	Description	Data
N/A	Ramp Length (in)	48.0	Yes	BlendTrans Slope (%)	1.9
No	Ramp Width (in)	46.0	Yes	BlendTrans XSlope (%)	0.9
N/A	Flare Type LT	N/A	N/A	Flare Type RT	N/A
N/A	Flare Slope LT (%)	N/A	N/A	Flare Slope RT (%)	N/A
N/A	Flare Traversable LT?	N/A	N/A	Flare Traversable RT?	N/A
N/A	Landing Length (in)	N/A	N/A	DWS Provided?	N/A
N/A	Landing Width (in)	N/A	N/A	DWS Contrast?	N/A
N/A	Landing Slope (%)	N/A	N/A	DWS Length (in)	N/A
N/A	Landing X Slope (%)	N/A	N/A	DWS Full Width?	N/A
N/A	Landing Curb? (Y/N)	N/A	N/A	DWS Offset (in)	N/A
N/A	Shared Landing?	N/A			
N/A	Gutter Ponding?	N/A	N/A	Gutter Slope (%)	N/A
N/A	Gutter Lip Ht (in)	N/A	N/A	Gutter X Slope (%)	N/A
N/A	Painted X Walk1?	No	N/A	Painted X Walk2?	No
	X Walk 1 Direction	To SE		X Walk 2 Direction	To NE
	X Walk 1 Width (in)	N/A		X Walk 2 Width (in)	N/A
	X Walk 1 Slope (%)	1.0		X Walk 2 Slope (%)	0.5
	X Walk 1 X Slope (%)	2.1		X Walk 2 X Slope (%)	0.4

N/A	Ramp inside XWalk1?	N/A	N/A	Ramp inside XWalk2?	N/A
	Road Slope (%)	1.4		Clear Space?	N/A
	Road X Slope (%)	1.0	N/A	Clear Space to XWalk (in)	N/A
N/A	Any Obstructions?	N/A	N/A	Storm Grate/Utility Hazard?	N/A
	Obstruction Type			Storm Grate/Utility Type	
		N/A			N/A
			Yes	Surface Condition? (G/P)	Good
			No	Curb Slope (%)	14.7

Remove & Replace Curb Ramp With Two New Directional Ramps or Equivalent.
