# Access Compliance Report

## Public Rights-of-Way

### (Curb Ramps)

| Intersection ID: 6364 | Main Street: SONOMA_VALLEY_DR | Cross Street: RHYNE_RD | Location: NE |

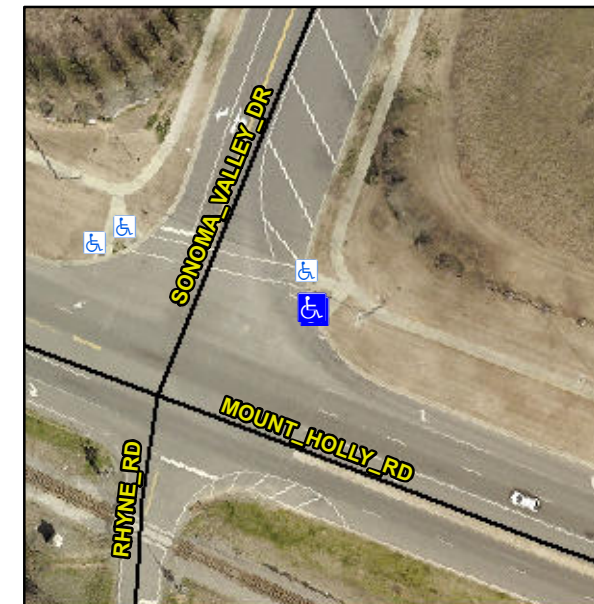
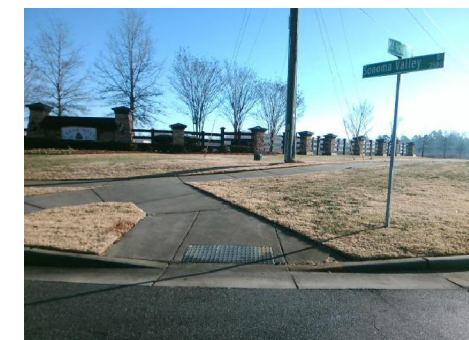
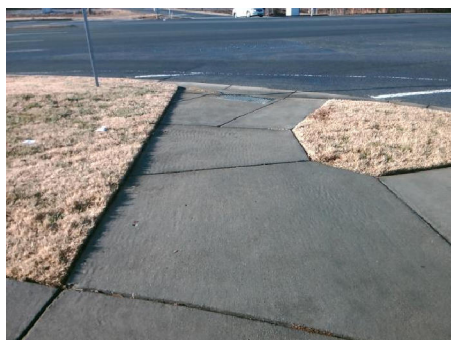
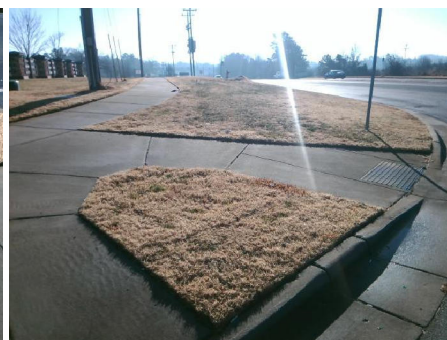
| ADA ID: 2EBB17C4B4E8 | Ramp Type: Perp | Initial Pass/Fail: Fail | Overall Compliance: No |

**Not Found, R304.2.2**

| Compliance | Description | Data | Compliance | Description | Data |
|---|---|---|---|---|---|
| N/A | Ramp Length (in) | 68.0 | No | Ramp Slope (%) | 9.0 |

**Remove & Replace Entire Ramp.**

Total Cost: \$ 1850.00
