Access Compliance Report

Public Rights-of-Way

(Curb Ramps)

Intersection ID: 24214	Main Street: HENSEY'S_WY	Cross Street: BEVERLY_CREST_BV	Location:	N
ADA ID: 2EBF2BB2784F	Ramp Type: Perp	Initial Pass/Fail: Fail	Overall Compliance: No	Severity Score: 12.5

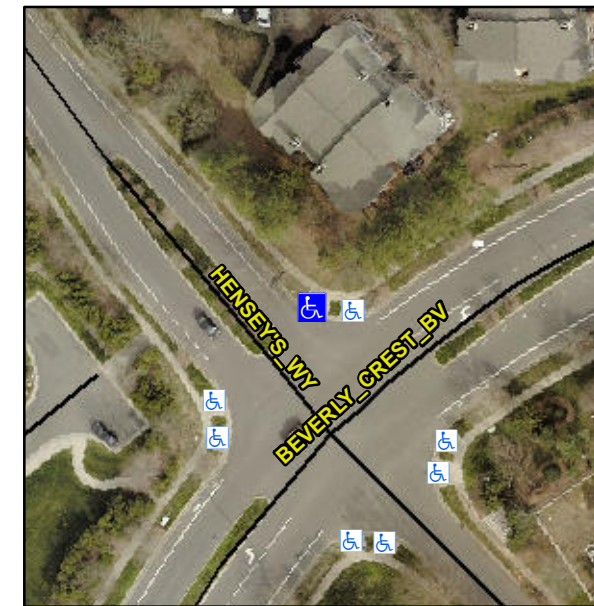
Not Found, R304.2.2

Compliance	Description	Data	Compliance	Description	Data
N/A	Ramp Length (in)	107.0	No	Ramp Slope (%)	8.8
Yes	Ramp Width (in)	91.0	Yes	Ramp XSlope (%)	0.2
N/A	Flare Type LT	N/A	N/A	Flare Type RT	N/A
N/A	Flare Slope LT (%)	N/A	N/A	Flare Slope RT (%)	N/A
N/A	Flare Traversable LT?	N/A	N/A	Flare Traversable RT?	N/A
N/A	Landing Length (in)	N/A	N/A	DWS Provided?	N/A
N/A	Landing Width (in)	N/A	N/A	DWS Contrast?	N/A
N/A	Landing Slope (%)	N/A	N/A	DWS Length (in)	N/A
N/A	Landing X Slope (%)	N/A	N/A	DWS Full Width?	N/A
N/A	Landing Curb? (Y/N)	N/A	N/A	DWS Offset (in)	N/A
N/A	Shared Landing?	N/A			
N/A	Gutter Ponding?	N/A	N/A	Gutter Slope (%)	N/A
N/A	Gutter Lip Ht (in)	N/A	N/A	Gutter X Slope (%)	N/A
N/A	Painted X Walk1?	No	N/A	Painted X Walk2?	N/A
	X Walk 1 Direction	To SW		X Walk 2 Direction	N/A
N/A	X Walk 1 Width (in)	N/A	N/A	X Walk 2 Width (in)	N/A
	X Walk 1 Slope (%)	2.2		X Walk 2 Slope (%)	N/A
	X Walk 1 X Slope (%)	0.3		X Walk 2 X Slope (%)	N/A

Remove & Replace Entire Ramp.
